SERVICE BULLETIN

Service Bulletin No. / Date: SB TMG 125-1020 P1, Initial Issue / January 27, 2016

Subject: Gearbox Oil Leak Inspection

Type affected: TAE 125-02-99 and TAE 125-02-114

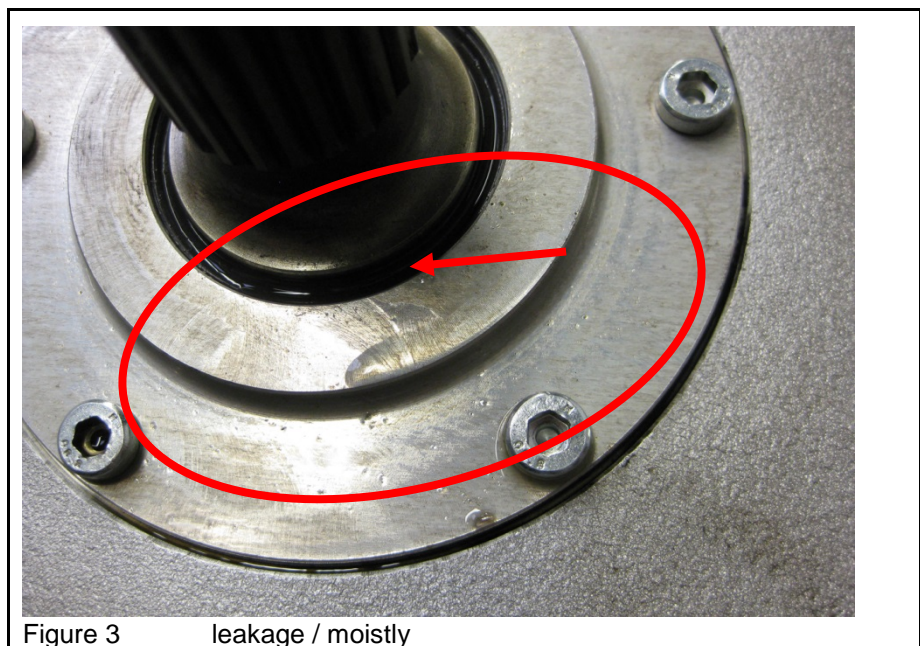
- If there is a leakage or moisture, see Figure 3, replace the gearbox.

◆ Note: The clutch has to be replaced by the dual mass flywheel in each case.
