SB TMG 651-1003 P1

SERVICE BULLETIN

Subject: Turbocharger Clamp Replacement

Type affected: All Piper PA 28 with TAE 125-01 and TAE 125-02-99

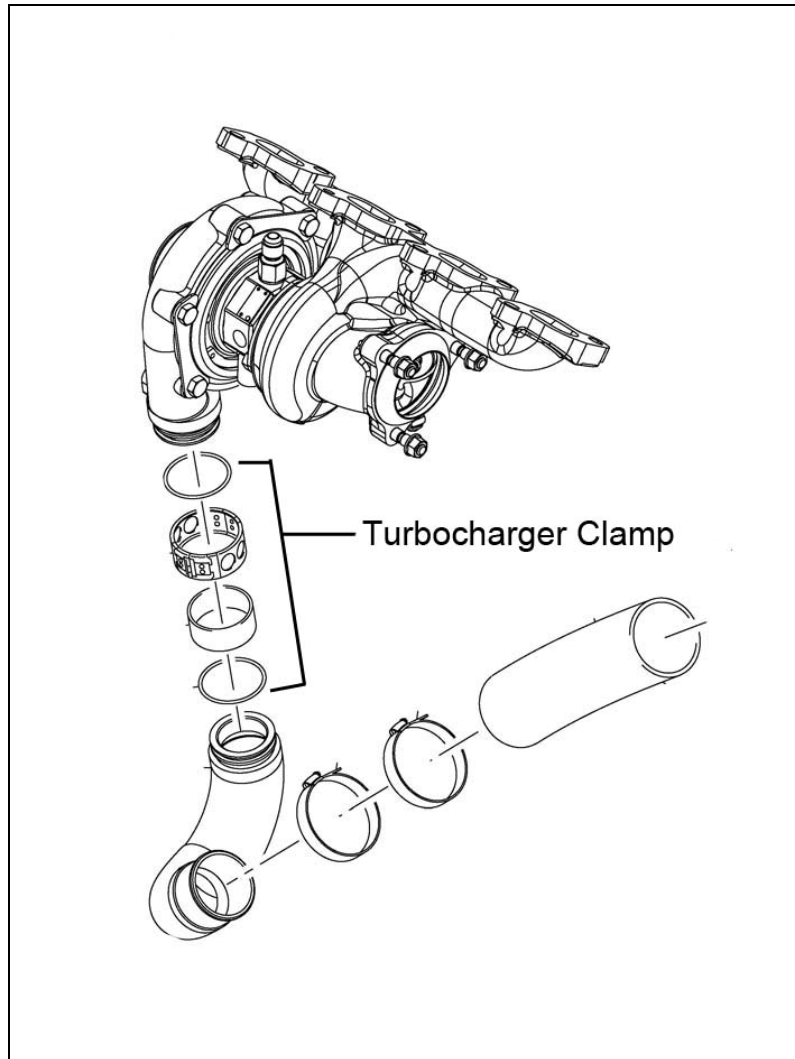
Figure 1

Reason: Possible failure of the clamp during flight

1. Remove the turbocharger clamp:

- Make sure that the engine is cold before starting work at the engine.
- Remove the turbocharger clamp including the inner ring and the O-rings.
- **CAUTION:** When opening the turbocharger system, pay special attention to prevent contamination.
