SB TMG 651-1006 P1

# SERVICE BULLETIN PRIORITY 1 - SAFETY

Turbocharger hose replacement

All Piper PA28 with TAE 125-02-99

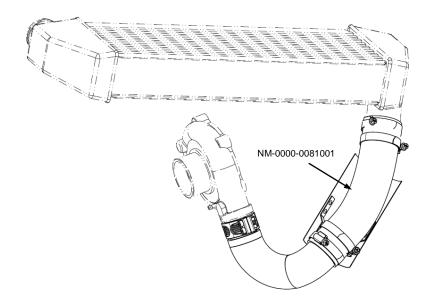
### 1. Check the installed turbocharger hose:

- Check if hose NM-0000-0081001 is installed.
- ◆ Note: NM-0000-0081001 is a blue hose.
- If installed, check the TSN of NM-0000-0081001 and replace the hose i.a.w. the following criteria:
  - TSN < 900 flight hours → not later than the 900h inspection
  - TSN > 900 flight hours  $\rightarrow$  with the next maintenance inspection

Due to field failures the turbocharger hose NM-0000-0081001 should be replaced by an improved version at a maximum lifetime of <u>900 flight hours</u>.
