SB CG 651-1009 P1, Rev.1

SERVICE BULLETIN

Subject: Turbocharger hose replacement

Type affected: Piper PA-28 with TAE 125-02-114

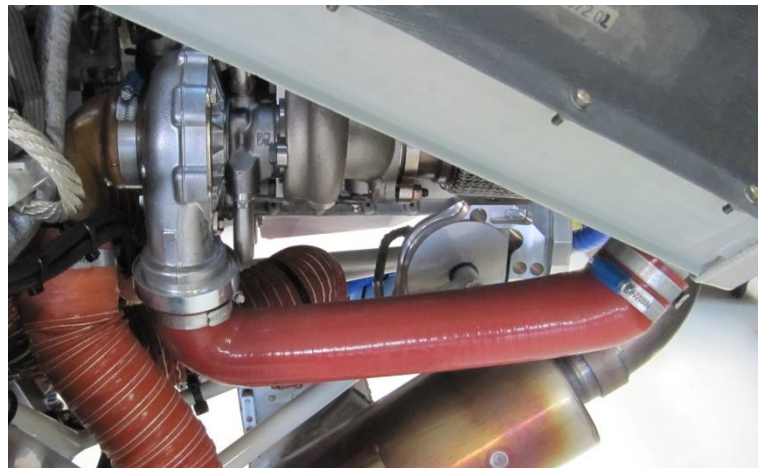
- Inspect the installed turbocharger hose and verify the part number TAE EPA 40-7520-H0131 01. Refer to figures below.
- If the installed hose is labelled with “BOOST products” and batch number “3101-001” the hose is critical and must be replaced. All hoses with deviating batch no. or other manufacturer label are uncritical.

Figure 1: turbocharger hose, installed

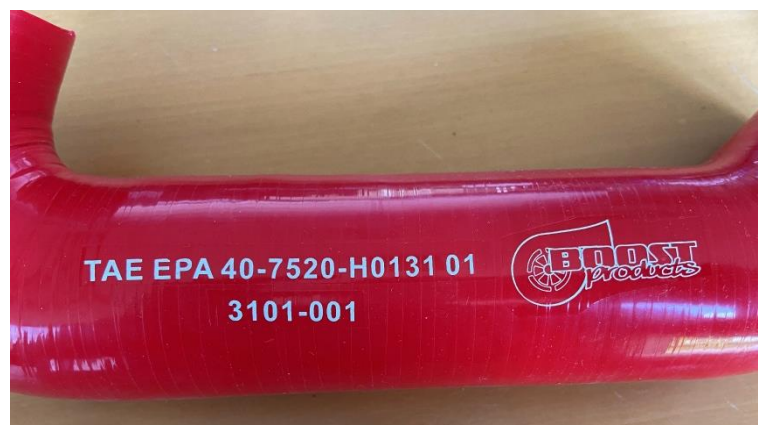
Remarks: Only the hoses of the manufacturer “BOOST products” with batch no. 3101-001 are affected. These hoses are not pressure stable and must be replaced.

▲ **WARNING:** Do not use the aircraft with installed turbocharger hose of the batch mentioned above, there is a high risk of hose bursting.

Figure 2: turbocharger hose of batch 3101-001

- Make sure that the engine is cold before starting work.
- Loosen the three hose clamps and remove the turbocharger hose.

- Install a factory new turbocharger hose P/N 40-7520-H0131 01 using three new hose clamps NM-0000-00170 01. Shorten the hose if needed.

Secure the hose with one clamp on turbocharger side and two clamps on intercooler side.
