SERVICE BULLETIN

Service Bulletin No. / Date: SB TMG 601-1006 P1, Initial Issue / November 05, 2014

Subject: Turbocharger Clamp Replacement

Type affected: All Cessna C172 (Reims F172) with TAE 125-01, TAE 125-02-99 and TAE 125-02-114

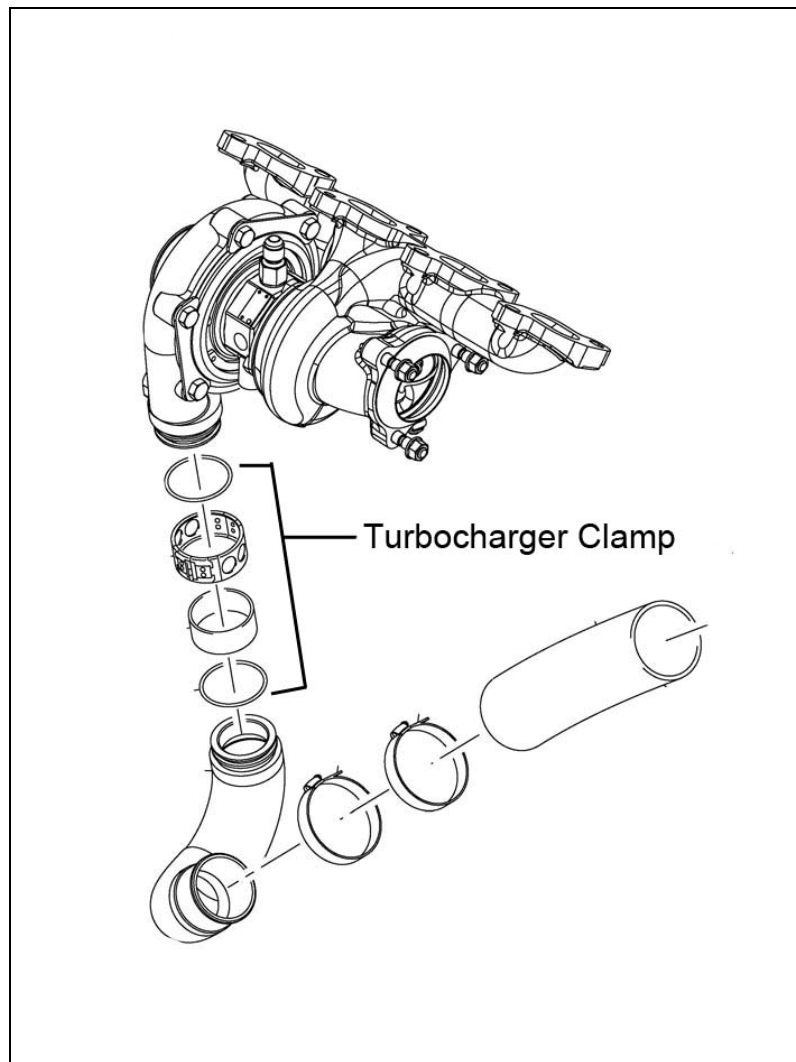
Figure 1

Reason: Possible failure of the clamp during flight

- Make sure that the engine is cold before starting work at the engine.
- Remove the turbocharger clamp including the inner ring and the O-rings.
- **CAUTION:** When opening the turbocharger system, pay special attention to prevent contamination.
