SB TMG 651-1004 P1, Rev. 2

SERVICE BULLETIN

Subject: Start Monitoring Loom and Mapping
Starter Info Board and mapping

Type affected: All Piper PA 28 with TAE 125-02 and Dual Mass Flywheel (DMF)

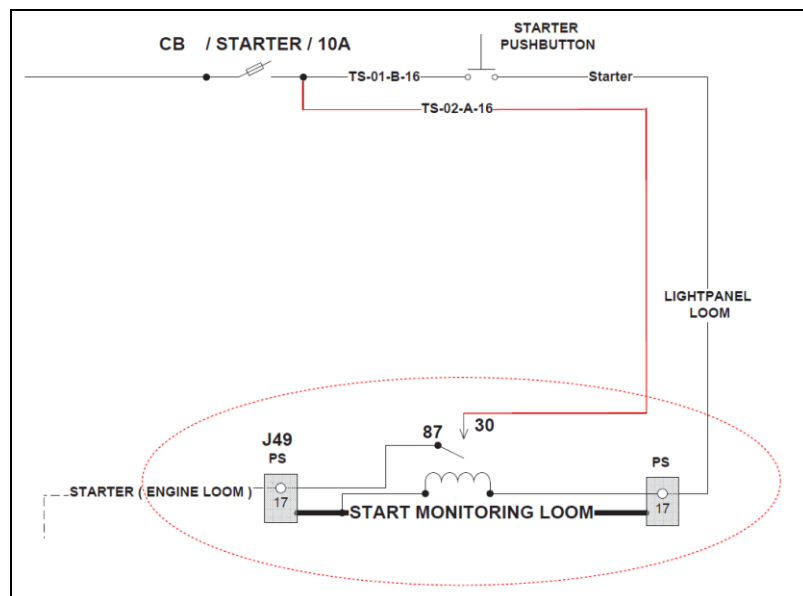
Figure 1a

Reason: To prevent an overload torque at the gearbox shaft during engine start.

- Install the appropriate start monitoring loom behind the cockpit panel between light panel loom and engine loom in accordance with Figure 1a.
