SB TMG 651-1008 P1

SERVICE BULLETIN

Subject: Rework of the engine mount

Type affected: Piper PA-28-181 ARCHER III with TAE 125-02-114 installation

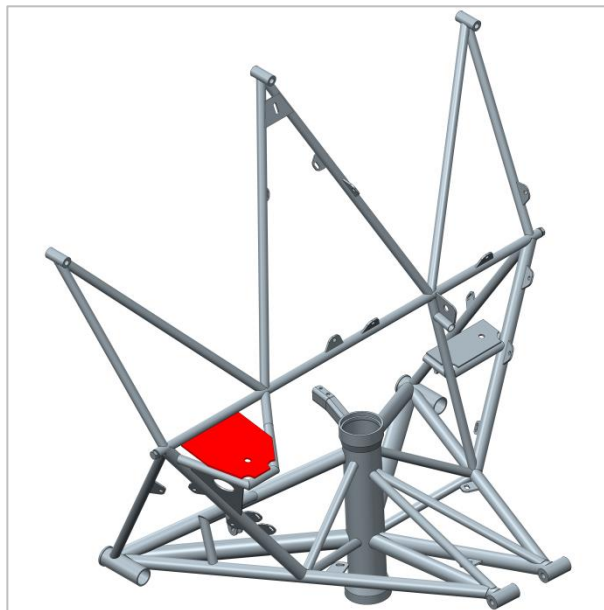
Figure 1: Affected plate

Reason: Incorrect position of the borehole on the right engine mount plate.
