SB TMG 691-1003 P2

Service Bulletin

Subject: Water separator

Type affected: All Diamond DA40 with TAE 125-02-114

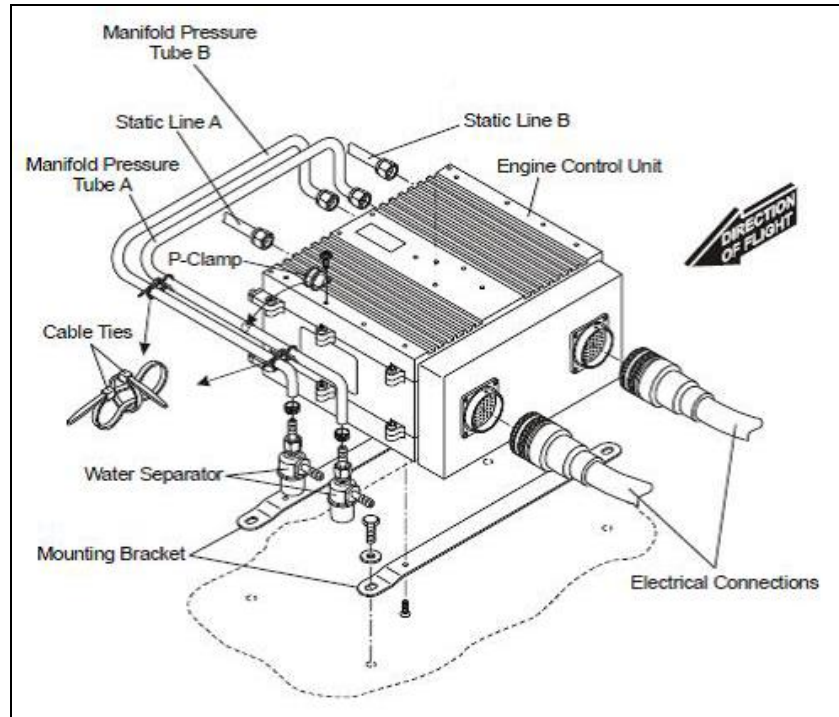
- Remove the pilot seat i.a.w. the original A/C AMM.
- Check if an original water separator system is installed.
See figure below.

- If no original water separator system is installed carry out the Diamond Service Bulletin RSB D4-083/1.
 - If an original water separator system i.a.w. RSB D4-083 is installed carry out the Diamond Service Bulletin RSB D4-083/1 (*improved water separator design with integrated membrane*) resp. install the water separators P/N 50-3940-E0020 03 (DAI P/N: D60-9076-14-01).
- ◆ Note: If the FADEC D48 has been replaced by a FADEC D4 please also take into account the Diamond Service Bulletin RSB D4-098.

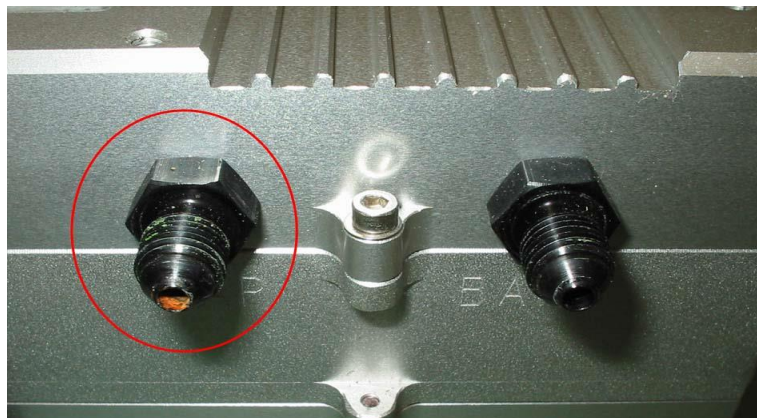
- Remove both MAP lines to check the FADEC fittings.
- Inspect the FADEC fittings on water, water residues, corrosion, sediments etc. Refer to the picture below.

If such damages are detected, the FADEC needs to be replaced.
