SB CG 125-1028 P1

## SERVICE BULLETIN

**Service Bulletin No. /** SB CG 125-1028 P1, Revision 1 / September 23, 2021  
**Date:**

**Subject:** Inspection / sealing of the cylinder head side cover

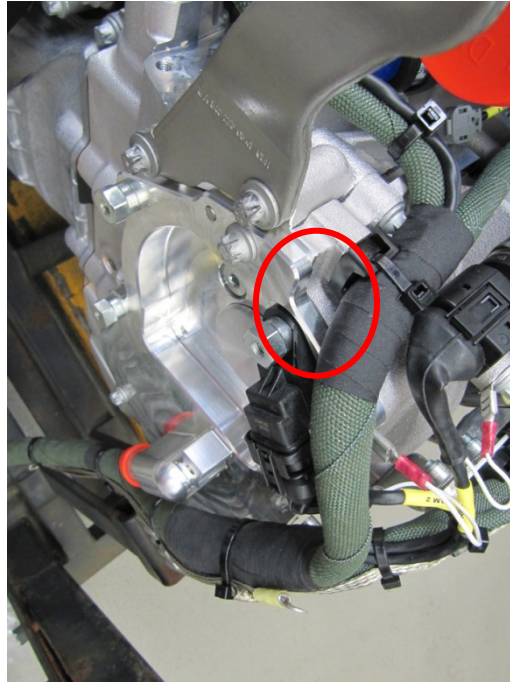
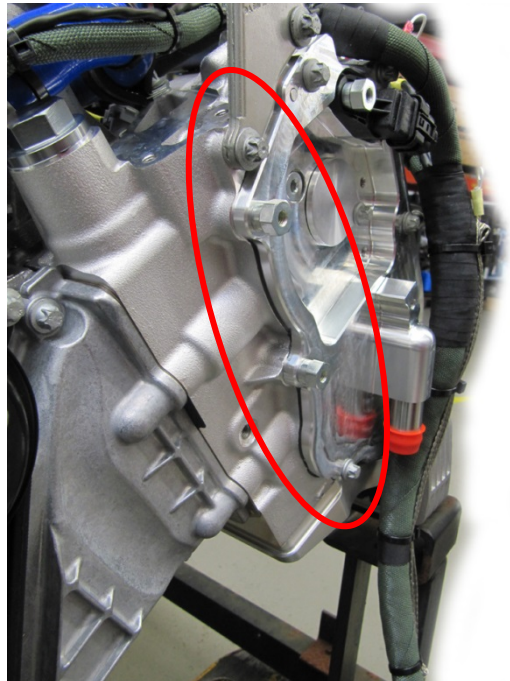
**Reason:** Possible oil leakage due to an improper sealing of the cylinder head side cover. The oil leak, if not corrected, can result in a damaged v-ribbed belt and possibly an engine shut down.

1. Check the side cover for oil leaks at the marked points. See Figure 1 and Figure 2.

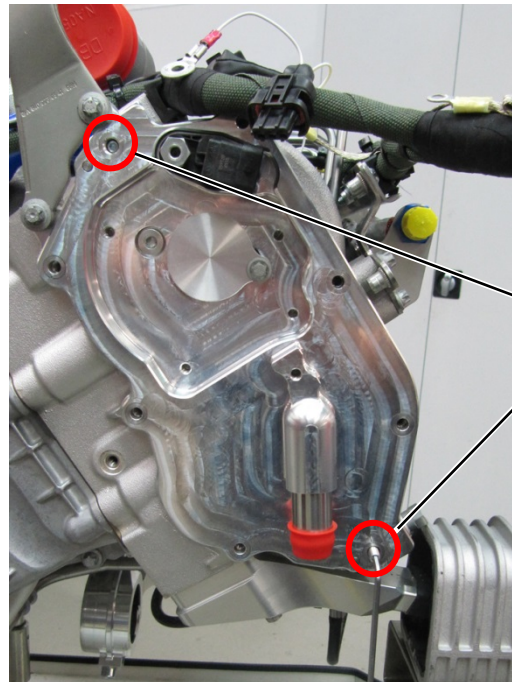
Figure 4 Loosen the side cover

hexagon socket set screw  
P/N NM-0000-0178101

5. Install two hexagon socket set screw P/N NM-0000-0178101. See figure 4.

◆ **Note:** Screw in the set screw until the base.

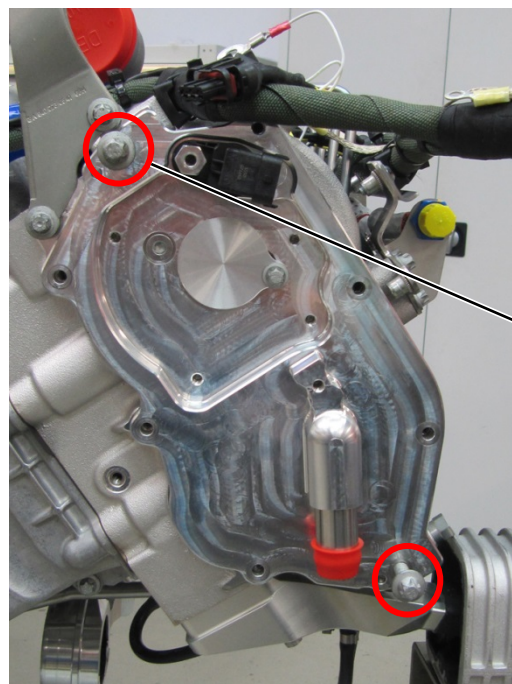
Figure 5 Loosen the side cover

screws with external torx  
P/N NM-0000-0048501

6. Install two screws with external torx P/N NM-0000-0048501 over the set screw and turn them in alternately until the side cover loosens from the cylinder head. See figure 5.

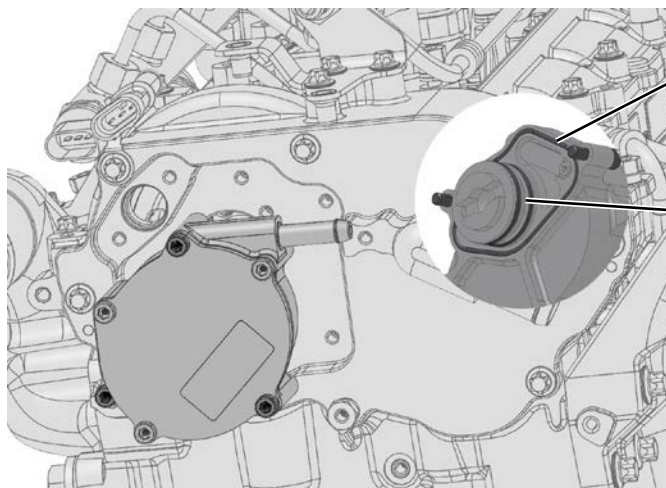
Figure 8 installation vacuum pump

o-ring  
P/N NM-0000-0215901

o-rings  
P/N M-0000-0206001

14. Install the vacuum pump (if it was installed) in accordance with RM-02-02, chapter 72-30.04 / 72-30.05. Replace the three o-rings P/N NM-0000-020601 / NM-0000-0215901.
