# SERVICE BULLETIN

**Service Bulletin No. / Date:** SB TMG 300-0001 P1, Revision 1 / May 4, 2022

**Subject:** Time Between Replacement (TBR) and Time Between Overhaul (TBO)

**Type affected:** Centurion 3.0 (CD-300)

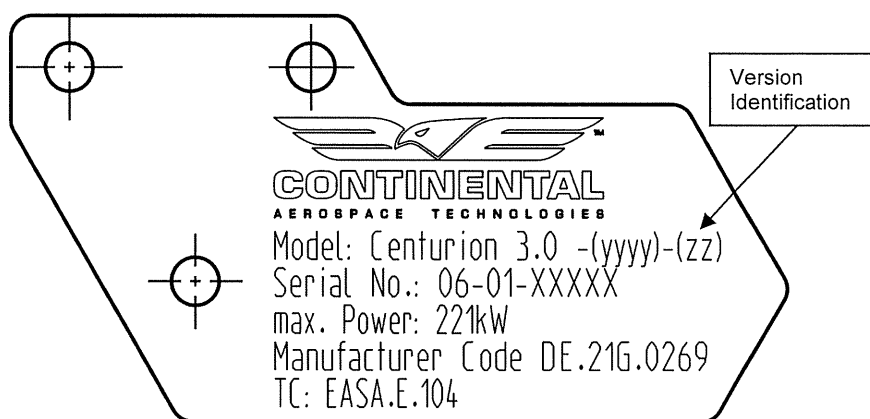
Fig. 1 Engine Version Identification

Identification of Engine Version on Type Plate:
