Service Letter

Service Bulletin No. SL TMG 000-1003, Initial Issue
Date: December 13, 2016

Subject: Correct Installation of V-Belt

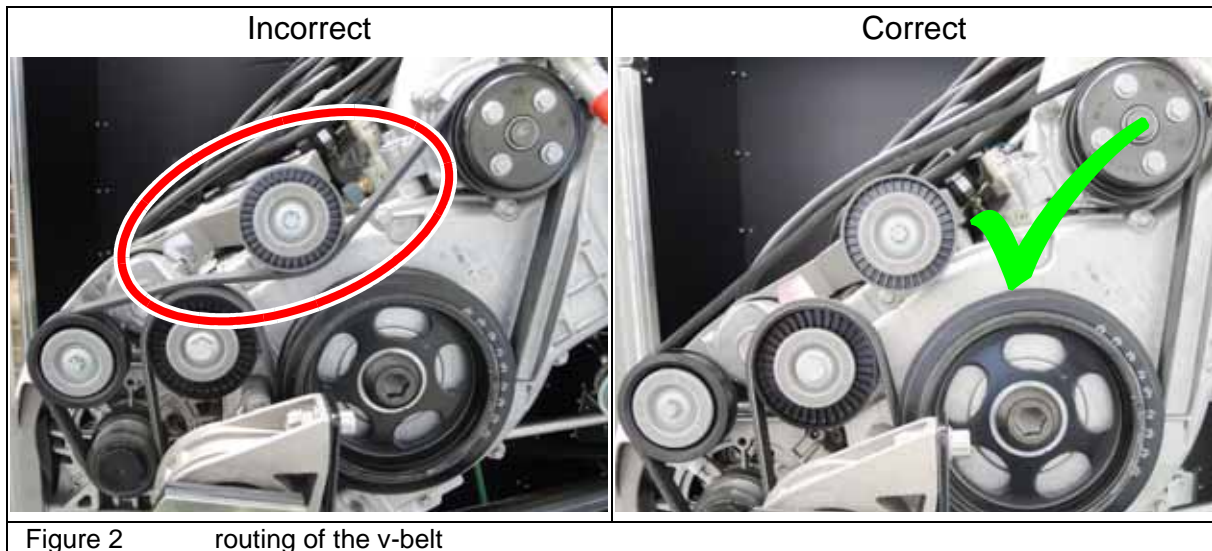
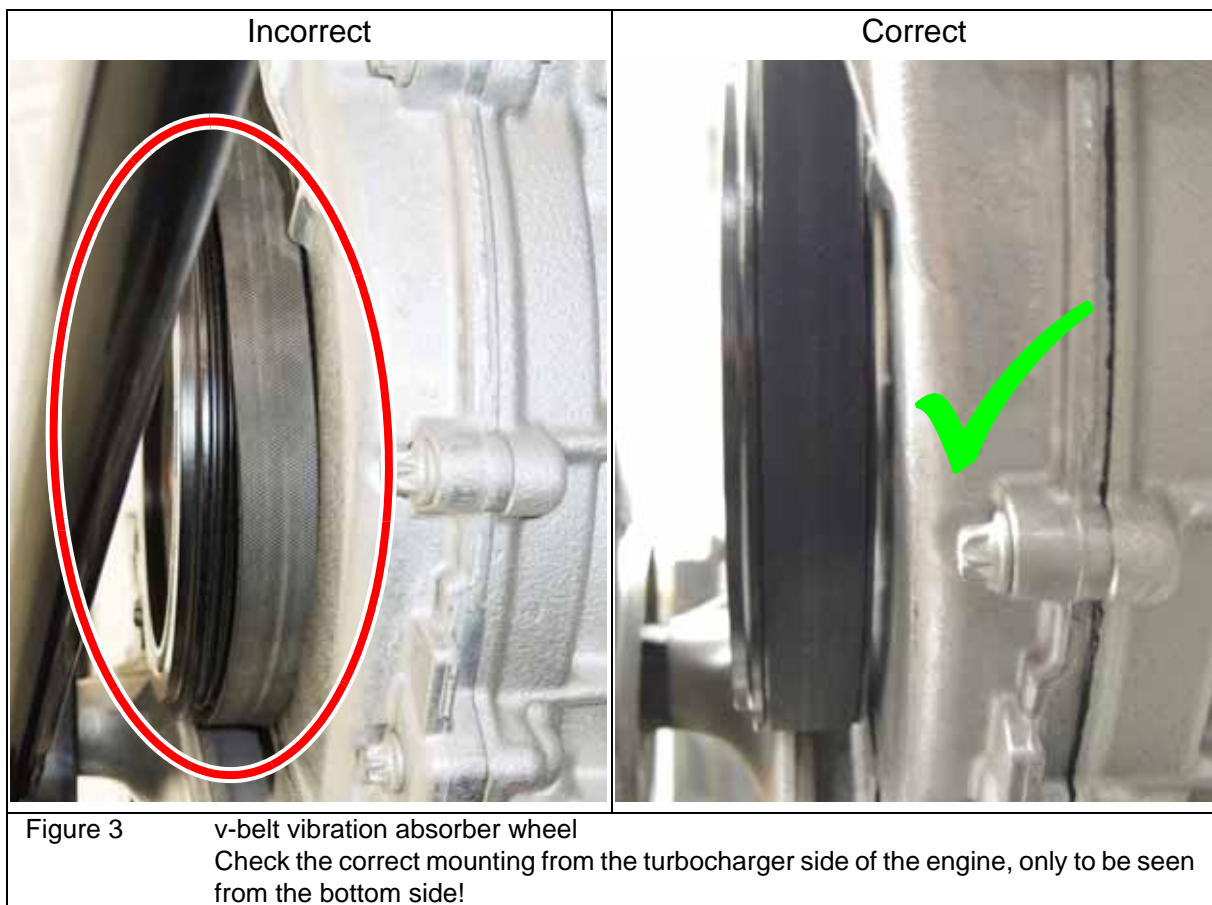
Following figures of incorrect and correct mounted v-belt to show what to check for:

An incorrect installed v-belt must be exchanged!
In accordance with RM-02-01 Chapter 07.0 / RM-02-02 Chapter 72-20.01.

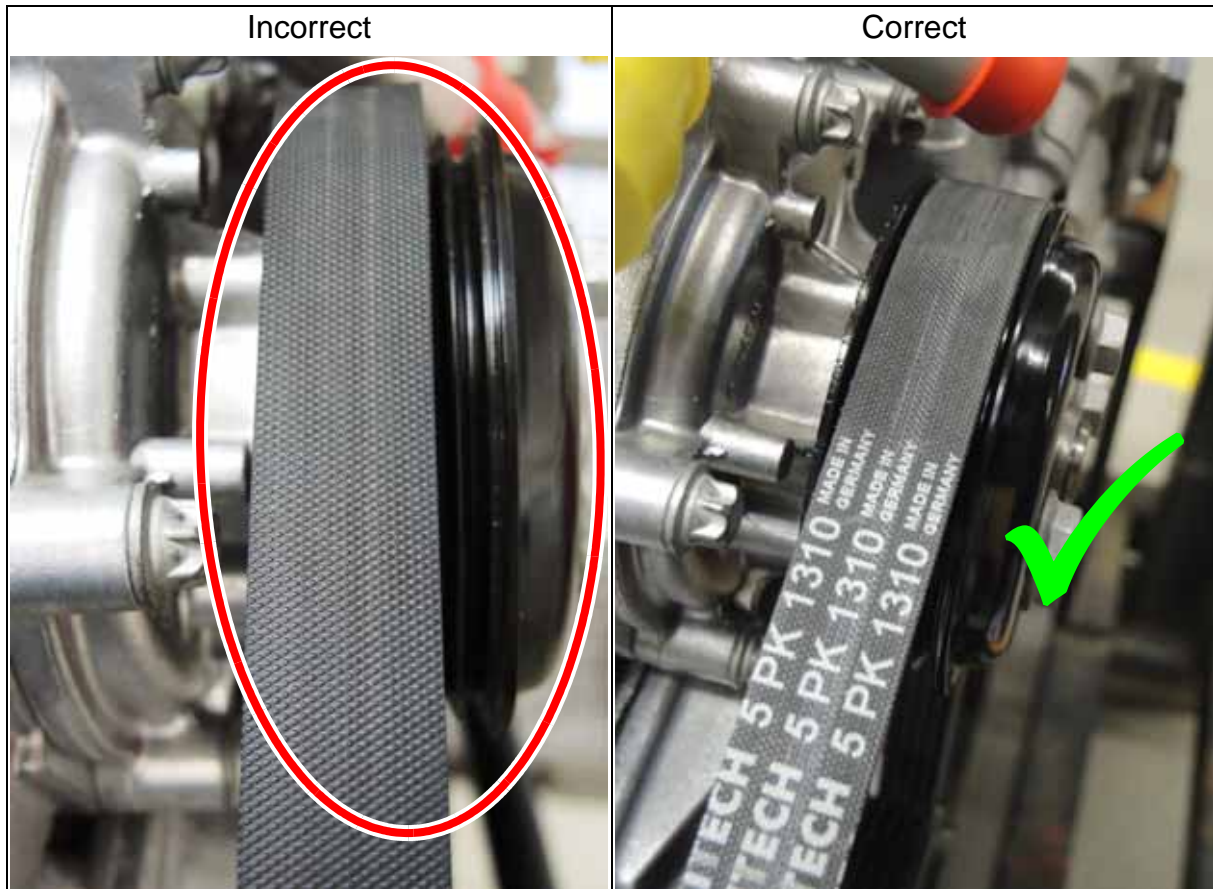
Figure 4 laying v-belt on coolant pump wheel

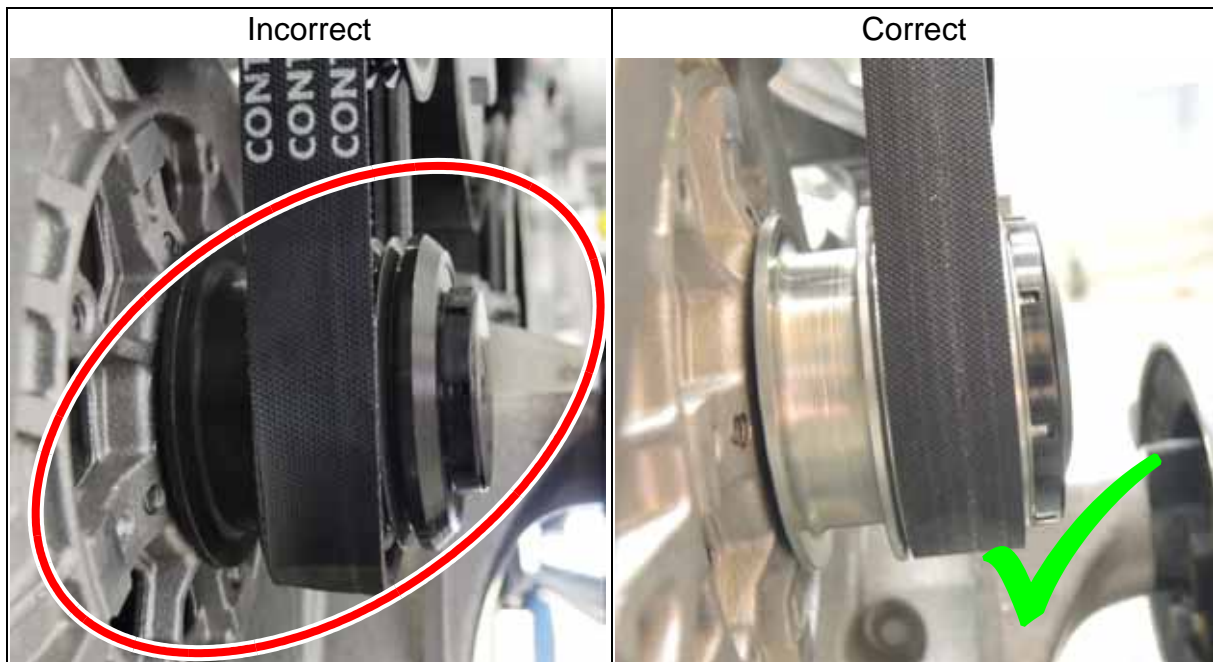
Figure 5 laying v-belt on alternator wheel
