## Service Letter

**Service Bulletin No.** SL TMG 000-1005, Initial Issue  
**Date:** July 26, 2017

**Subject:** Improper protection against chafing

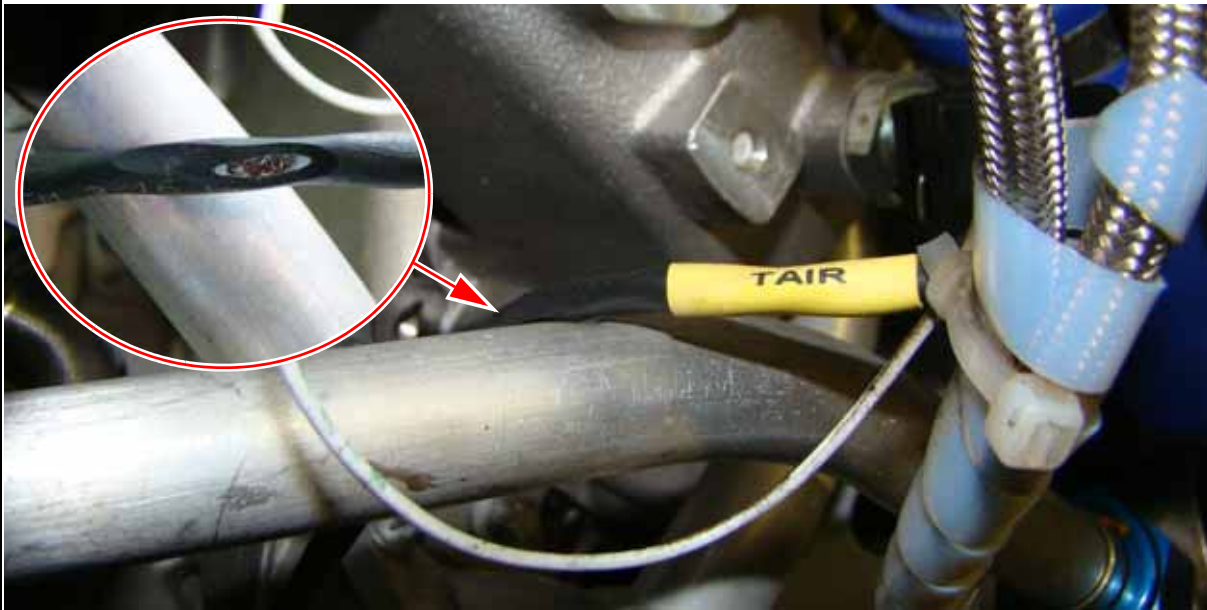
Incorrect

Figure 1 chafing spot: engine loom

**Correction:** Improper fixation and improper protection against chafing must be corrected.  
The following figures show examples of chafing.

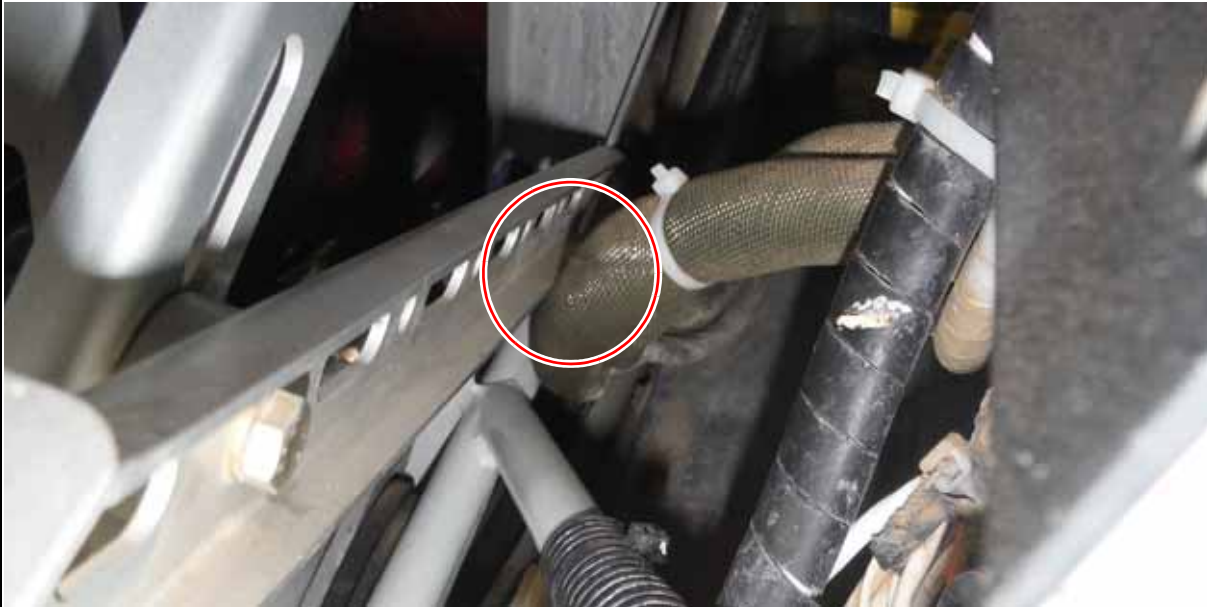
Incorrect

Figure 3 chafing spot: engine mount / engine loom

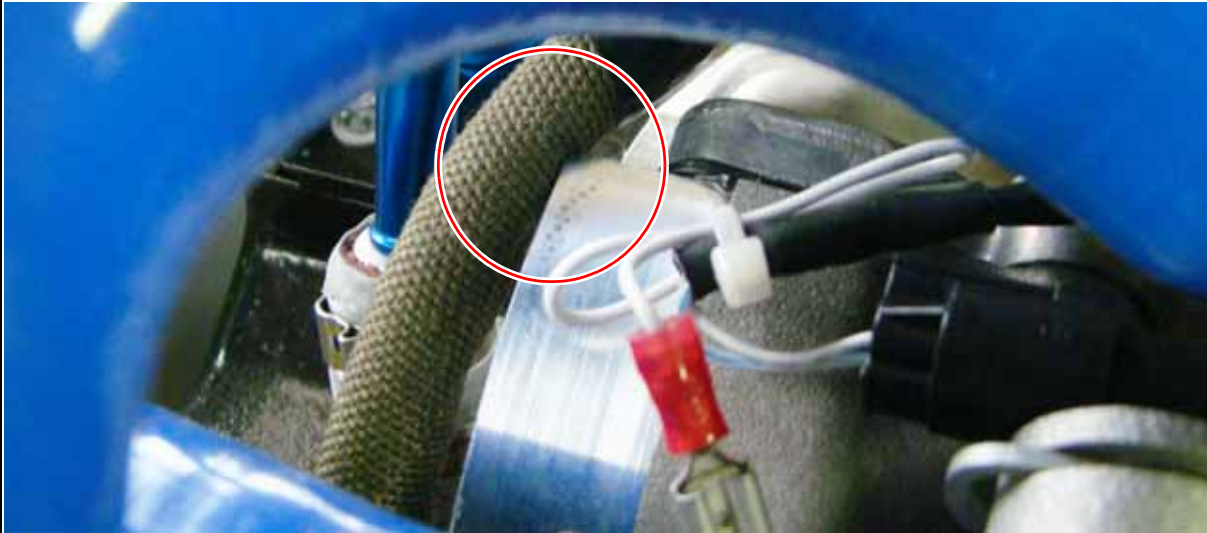
Incorrect

Figure 5 chafing spot: front cover / engine loom
