Service Letter

Service Bulletin No. SL TMG 000-1004, Initial Issue
Date: May 24, 2017

Subject: Improper fixation on steel pipes

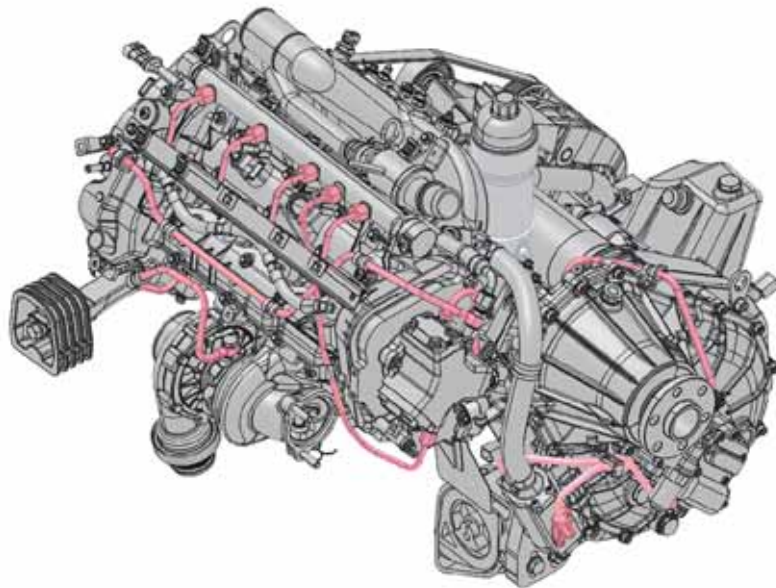
Reason: Maintenance problems were discovered due to improper fixation on steel pipes. This could lead to a breakage of a steel pipe and/or connection followed by a power loss or IFSD.

Figure 1 affected area

Correction: Improper fixation on steel pipes must be corrected.
The following figures show examples of improper fixations.

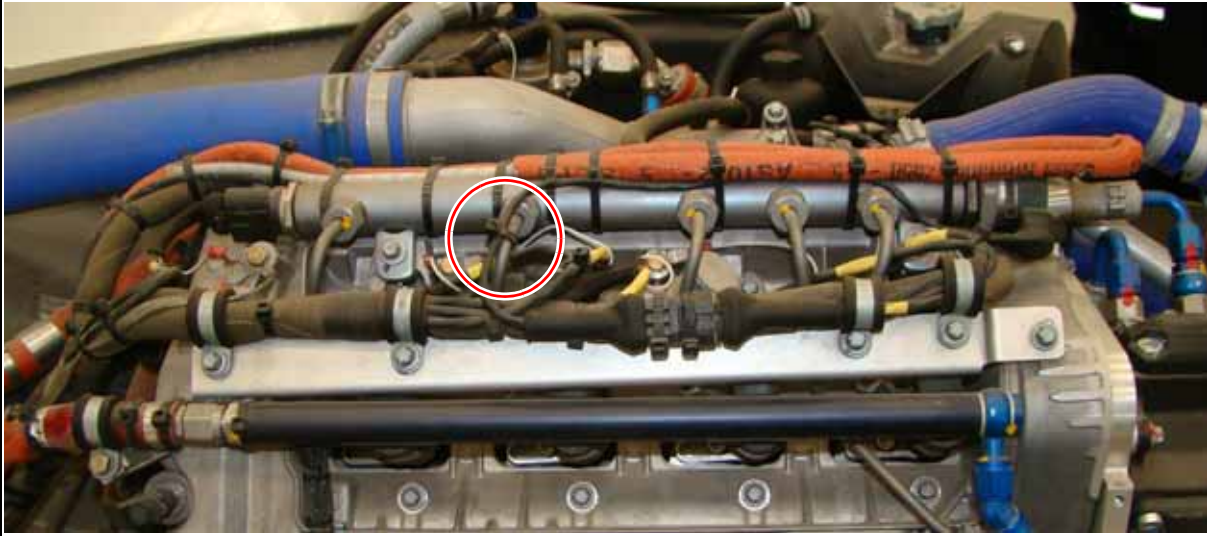
Incorrect

Figure 2 non-approved attachment: injector rail

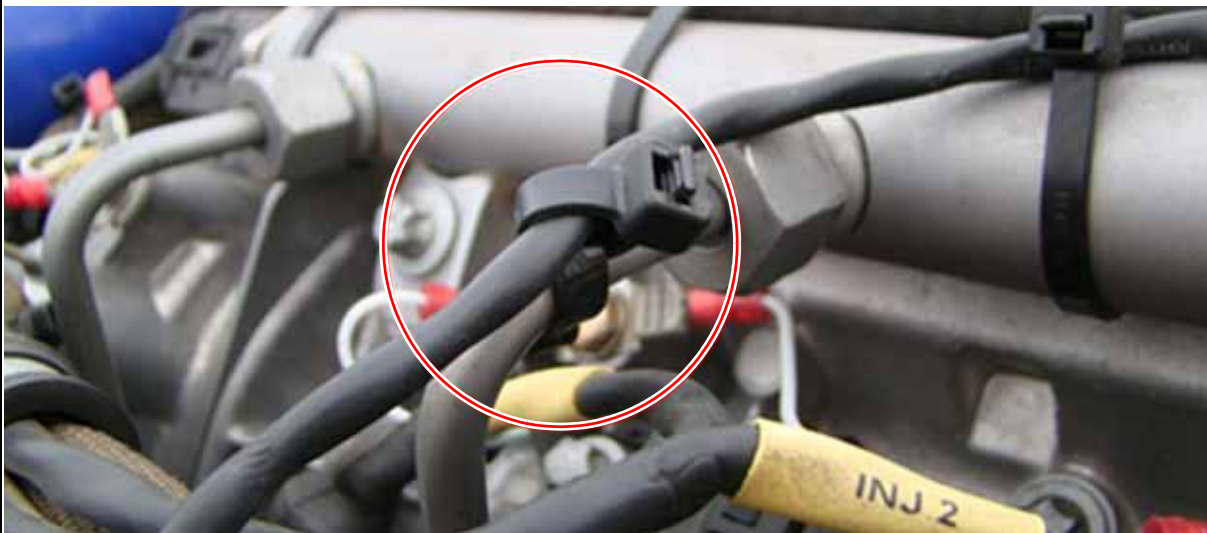
Incorrect

Figure 3 non-approved attachment: rail pressure pipe

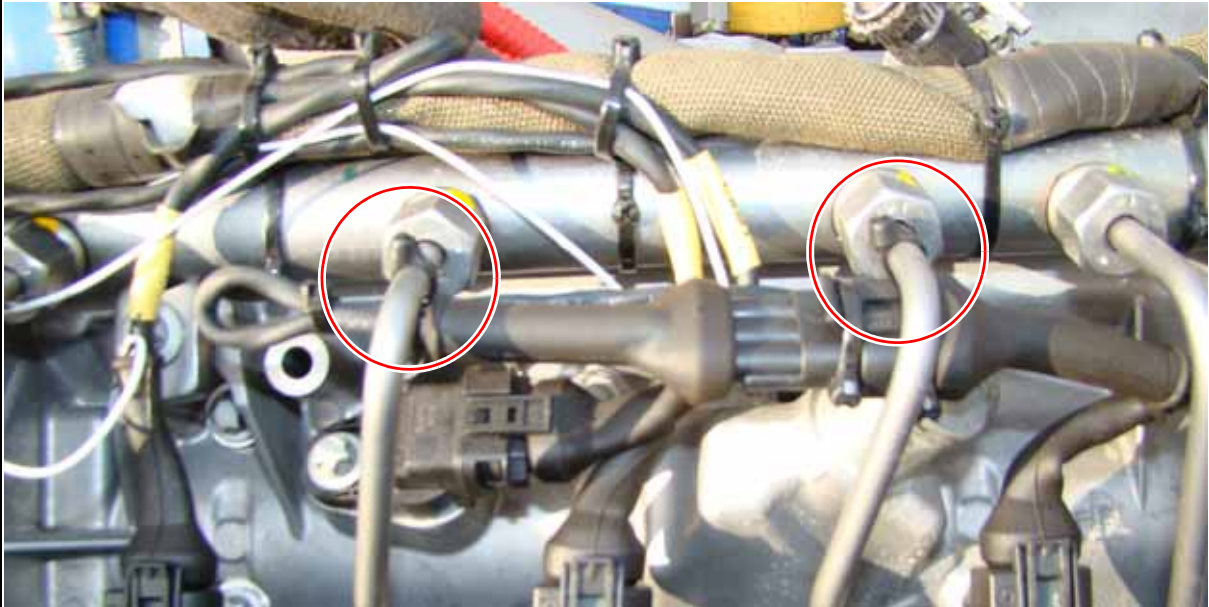
Incorrect

Figure 4 non-approved attachment: rail pressure pipe

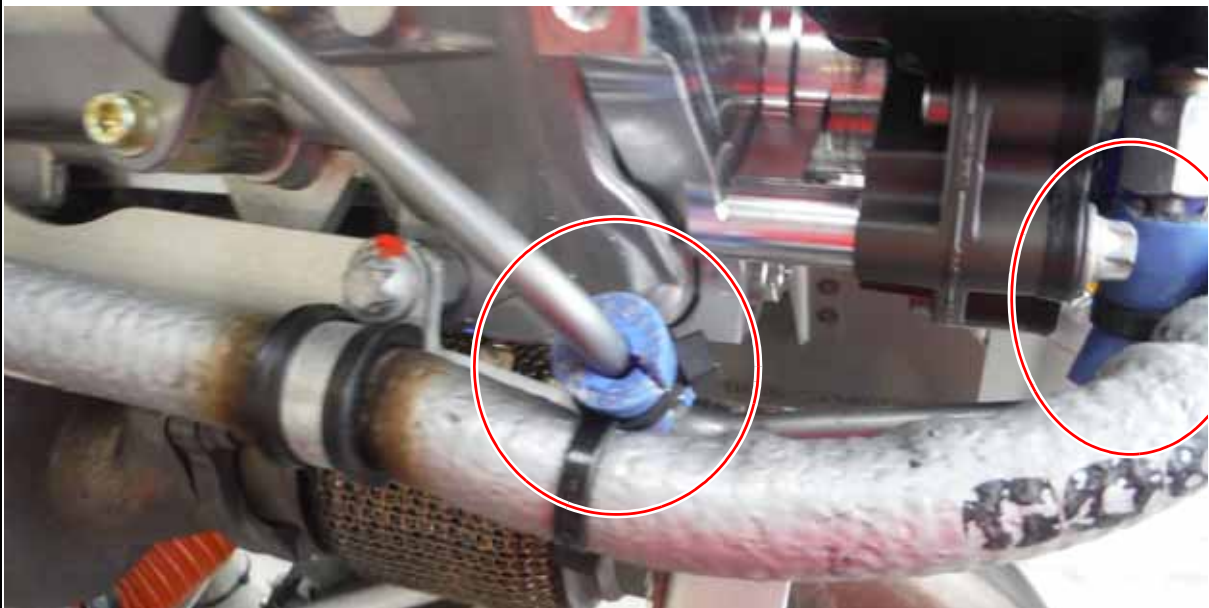
Incorrect

Figure 5 non-approved attachment: rail pressure pipe hpp to rail

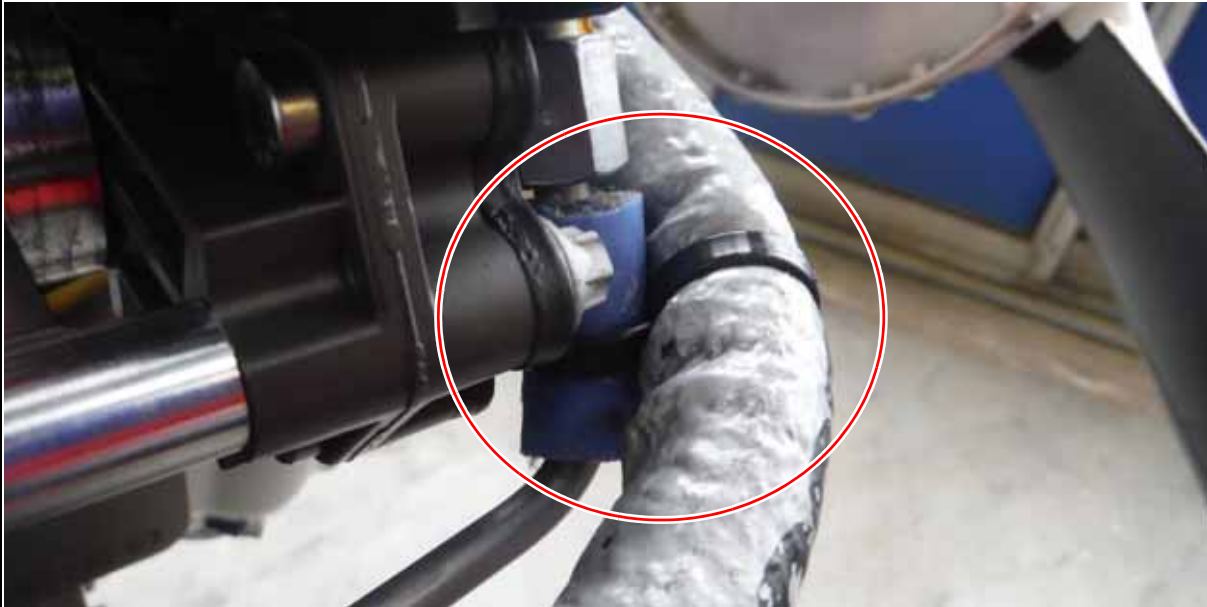
Incorrect

Figure 6 non-approved attachment: rail pressure pipe hpp to rail

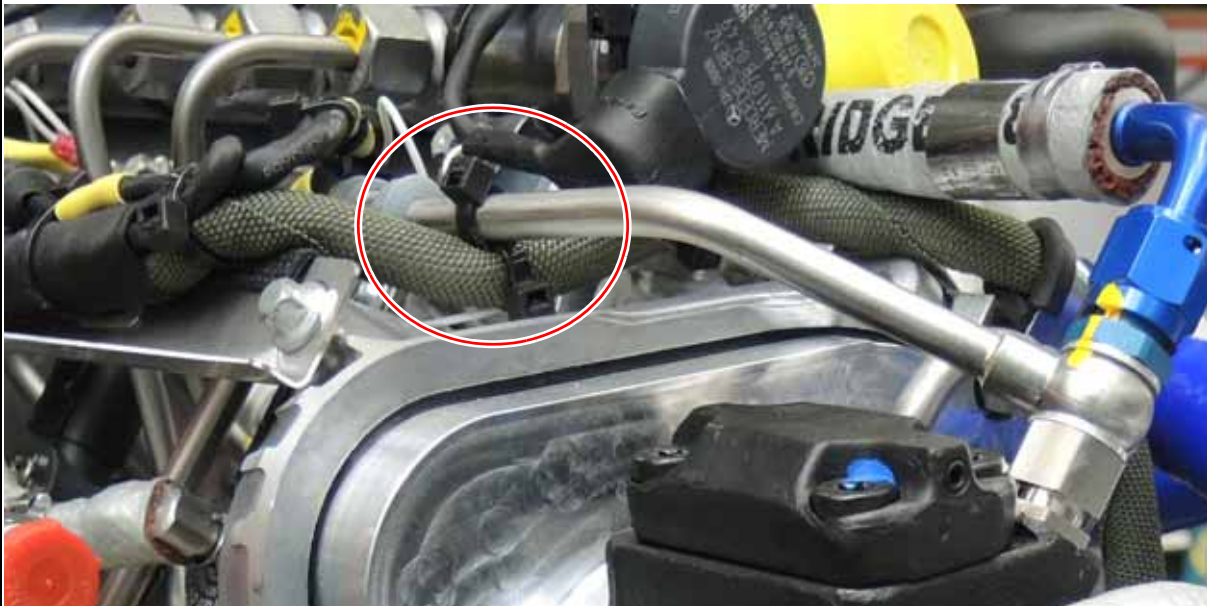
Incorrect

Figure 7 non-approved attachment: fuel return pipe

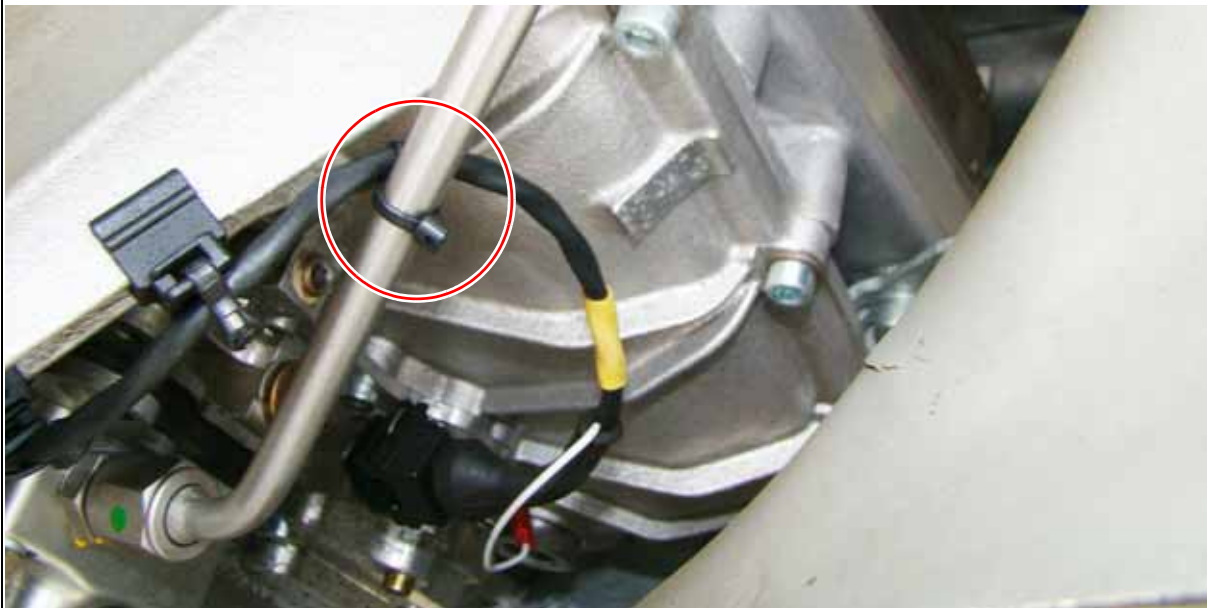
Incorrect

Figure 8 non-approved attachment: gearbox pipe
