Service Letter

Service Bulletin No. SL TMG 000-1006, Initial Issue
Date: September 15, 2017

Subject: oil contaminated electrical contacts

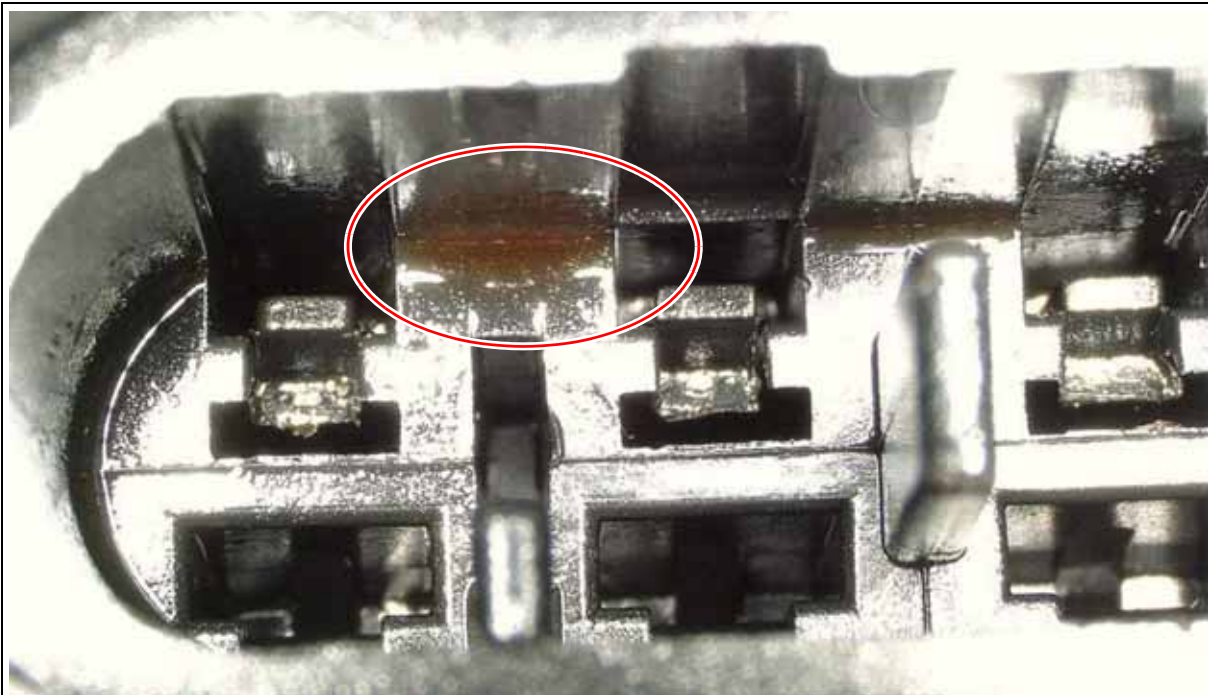
Reason: Maintenance problems were discovered due to oil contaminated contacts. This could lead to electrical contact problems and possibly to a malfunction.

Figure 1 oil contaminated plug housing

- Correction:** When changing or filling oil or coolant it must be ensured that the plugs are not contaminated with oil, coolant or other fluids.
Make sure that the plugs are properly closed or protected by appropriated plugs.
If plugs get contaminated, clean the contaminated components with appropriate silicone-free cleaner for electrical equipments, e.g. Rivolta S.L.X. 500 before starting the System.
Clean the plug and the socket.
- Remarks:** -
- Parts:** -
- Approval:** The technical information contained in this document has been approved under the authority of EASA Design Organisation Approval No. EASA.21J.010.
