Service Letter

Service Bulletin No. SL CG 125-1006, Initial Issue
Date: June 30, 2022
Subject: Modify the HPP J29 Plug Connection
Type affected: TAE 125-02-125 (CD-170)
Models affected: The following engine S/N are affected

Correction: Conversion of connector shells

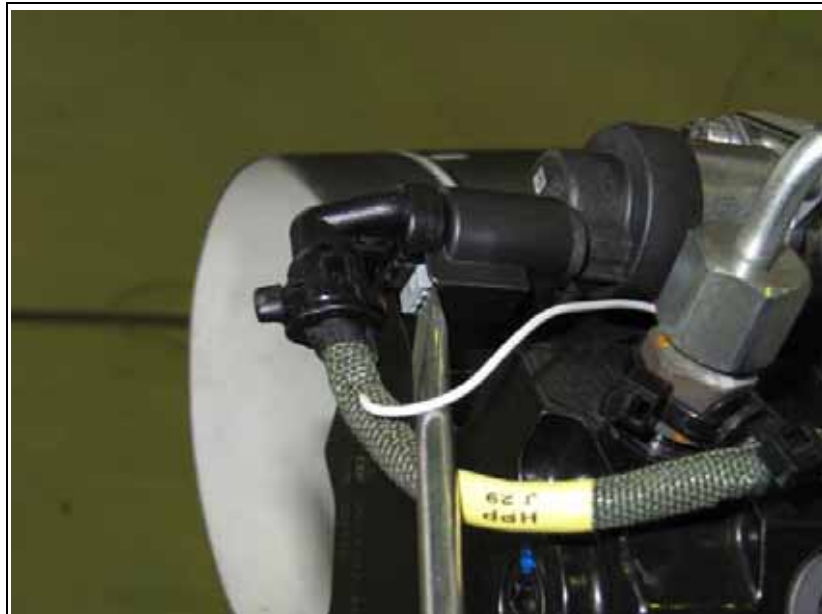
Figure 3

1. Unlock the secondary lock.

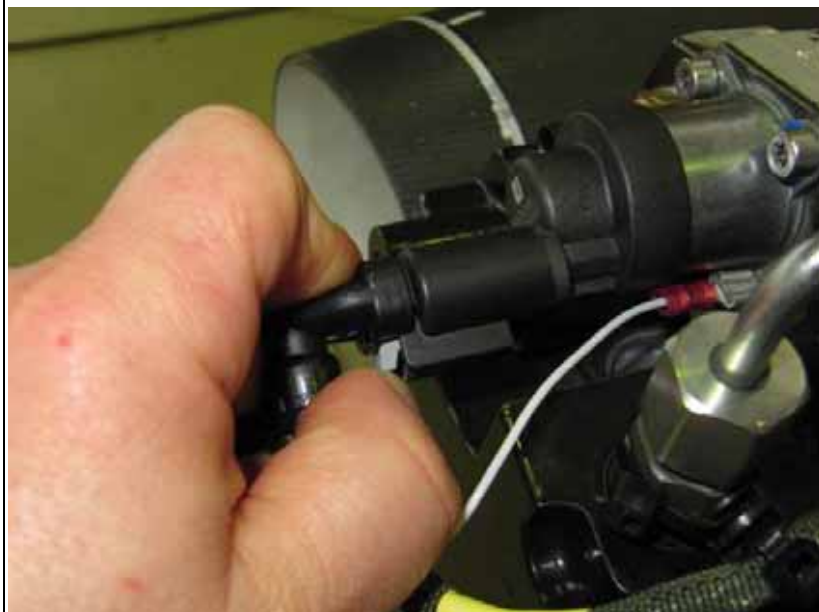
Figure 4

2. Press the secondary lock.

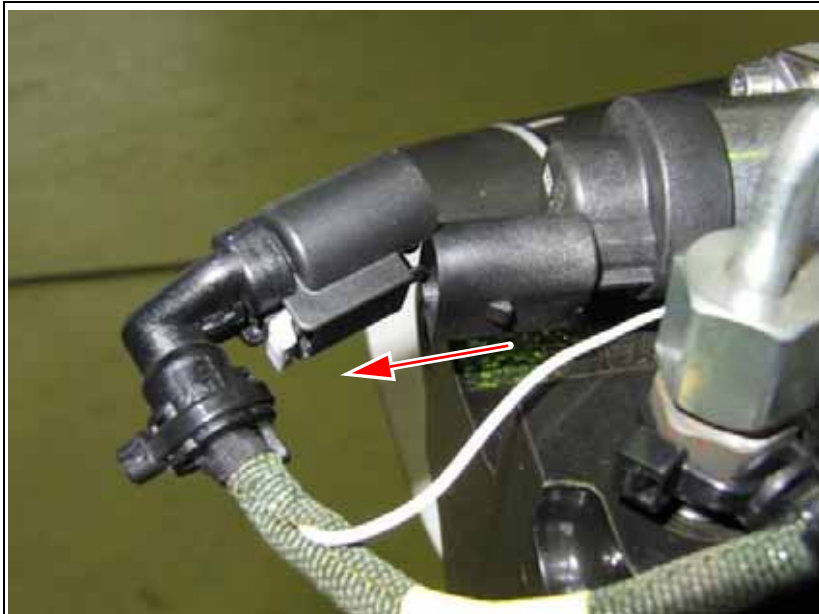
Figure 5

3. Disconnect the connector J29.

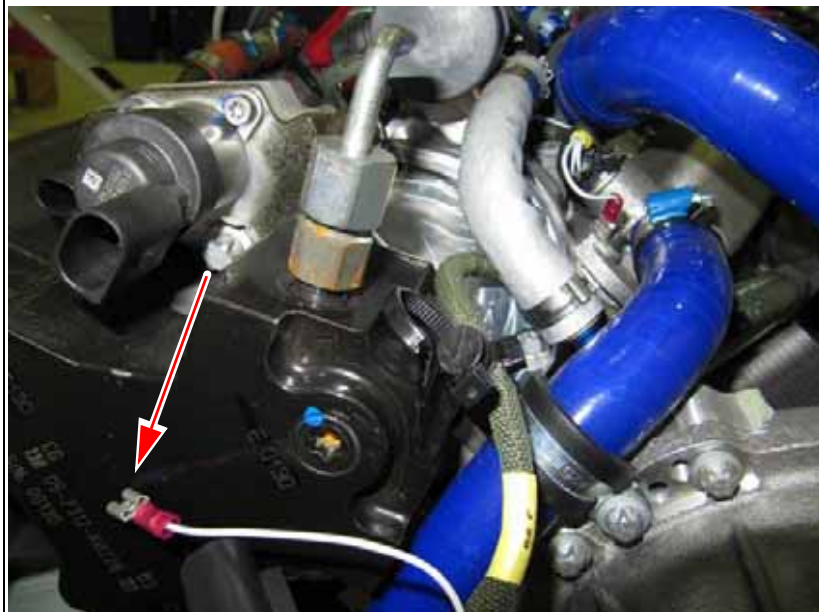
Figure 6

4. Disconnect the shield connection plug and cut the cable tie.

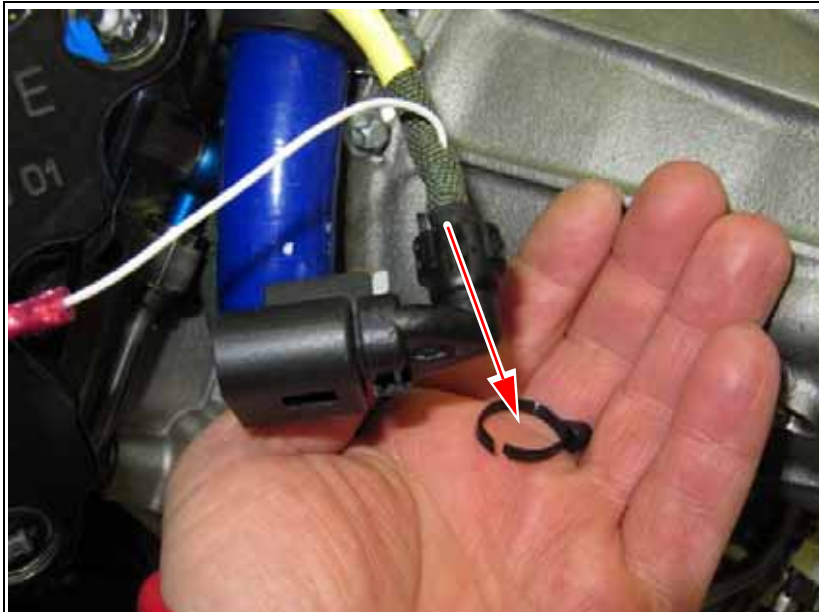
Figure 7

5. Cut and remove the cable tie from the backshell.

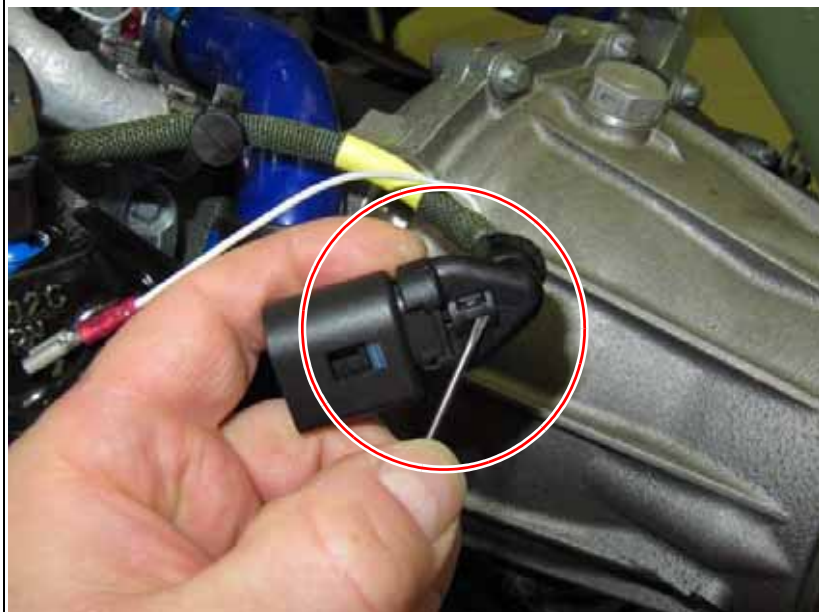
Figure 8

6. Open the first lock of the backshell.

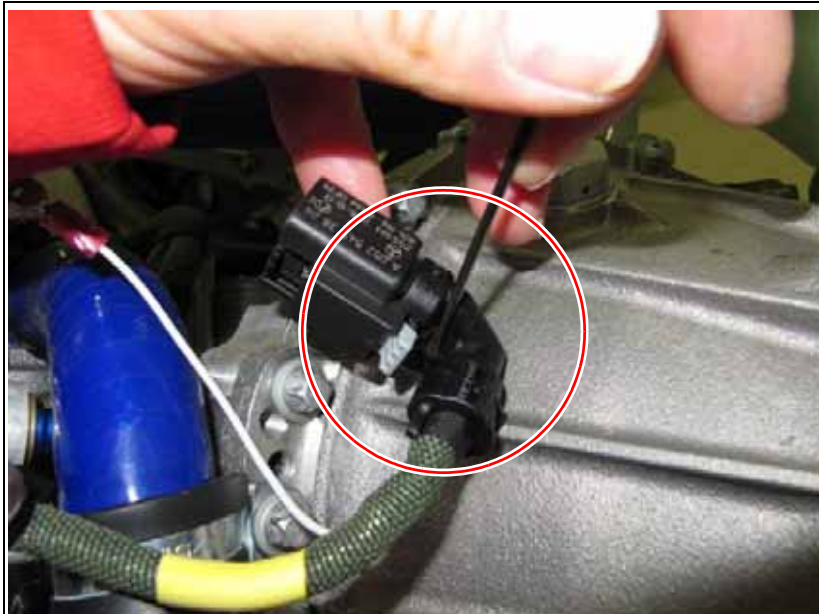
Figure 9

7. Open the second lock of the backshell.

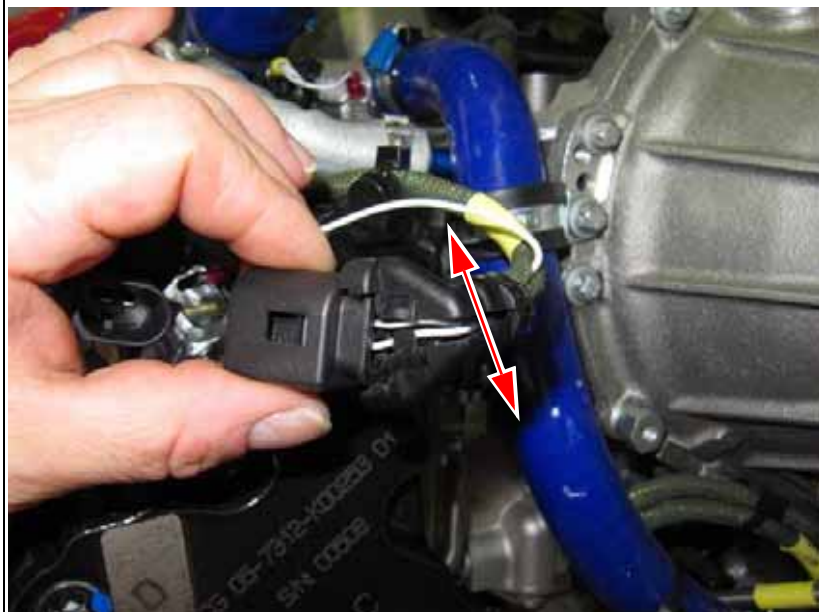
Figure 10

8. Open the backshell.

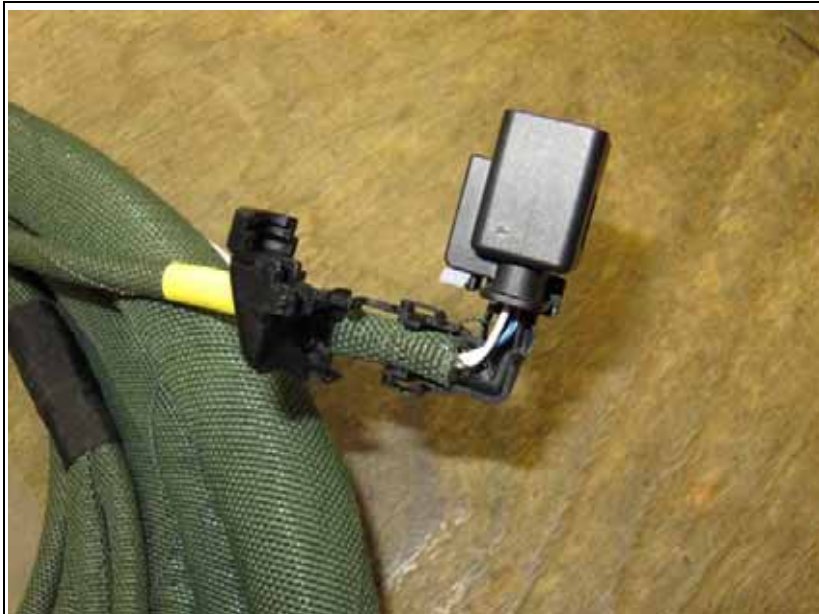
Figure 11 old alignment of the backshell

9. Remove the backshell.

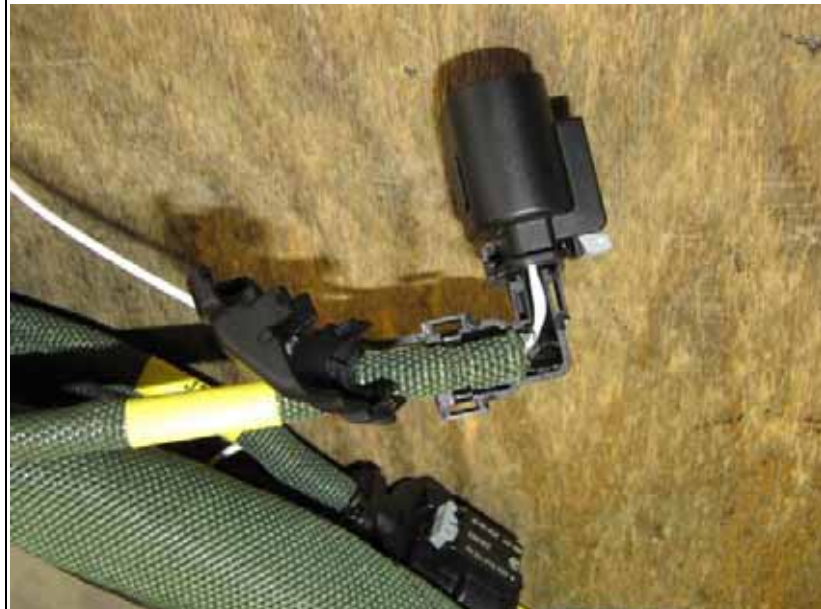
Figure 12 new alignment of the backshell

10. Installation of the new backshell (item 1) in new position. The backshell must be "on top" of the connector, see Figure 12.

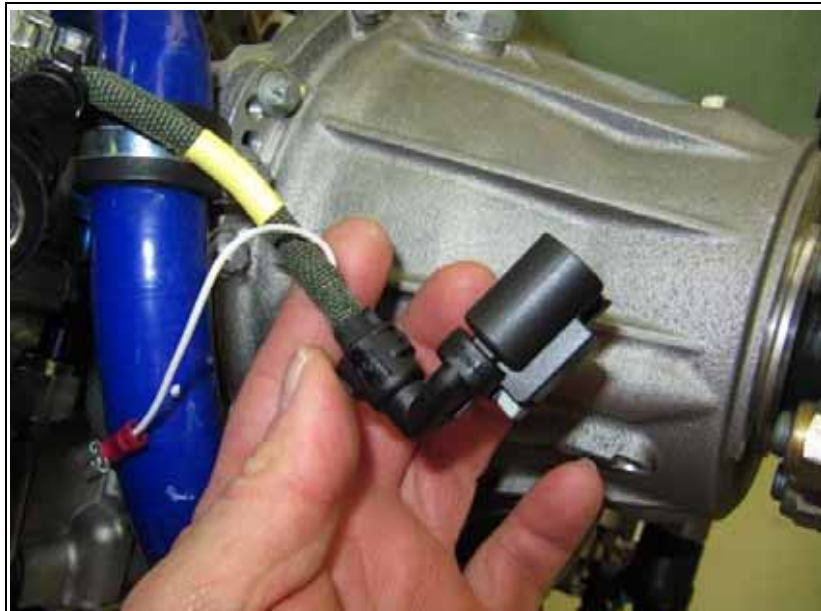
Figure 13

11. If the backshell is positioned correctly, it is pressed together until all locks are engaged. Secure with a cable tie (item 2).

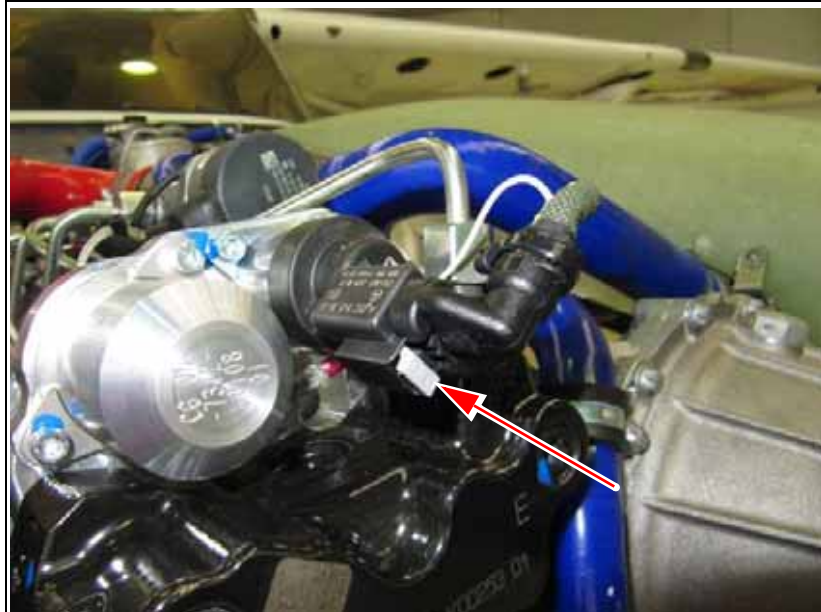
Figure 14

12. Connect connector J29 to the new pump push the secondary lock.

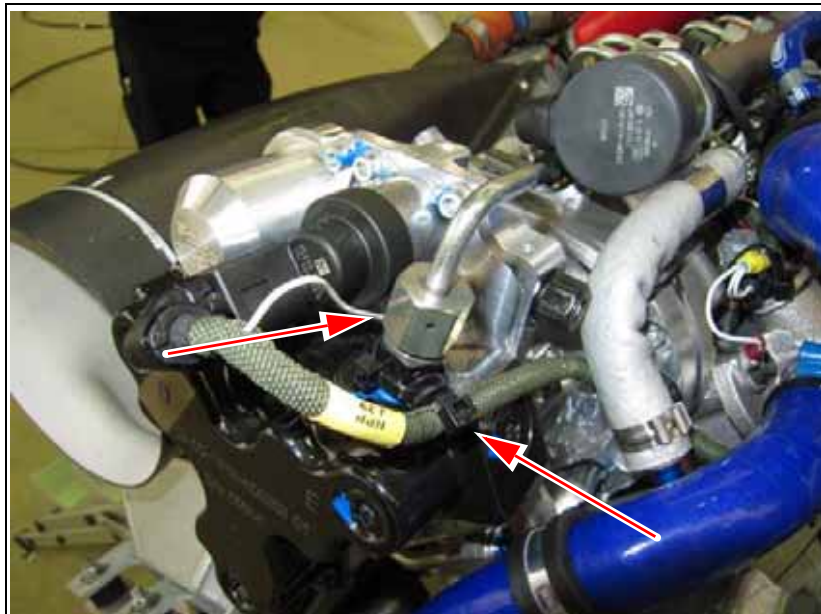
Figure 15

13. Connect shield connector and fix cable with cable tie.
