SB CG 601-1014 P1, Rev. 2

# SERVICE BULLETIN

**Subject:** Turbocharger hose replacement

**Type affected:** (Reims) Cessna (F) 172 with TAE 125-02-99 & -114

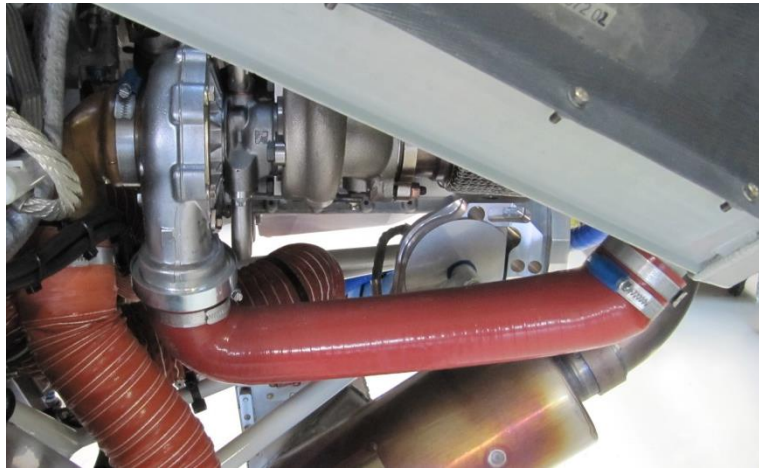
- Inspect the installed turbocharger hose and verify the part number TAE EPA 40-7520-H0131 01. Refer to figures below.
- If the installed hose is labelled with “BOOST products” and batch number “3101-001” the hose is critical and must be replaced. All hoses with deviating batch no. or other manufacturer label are uncritical.

Figure 1: turbocharger hose, installed

- Make sure that the engine is cold before starting work.
- Loosen the three hose clamps and remove the turbocharger hose.

- Install a factory new turbocharger hose P/N 40-7520-H0131 01 using three new hose clamps NM-0000-00170 01. Shorten the hose if needed.

Secure the hose with one clamp on turbocharger side and two clamps on intercooler side.

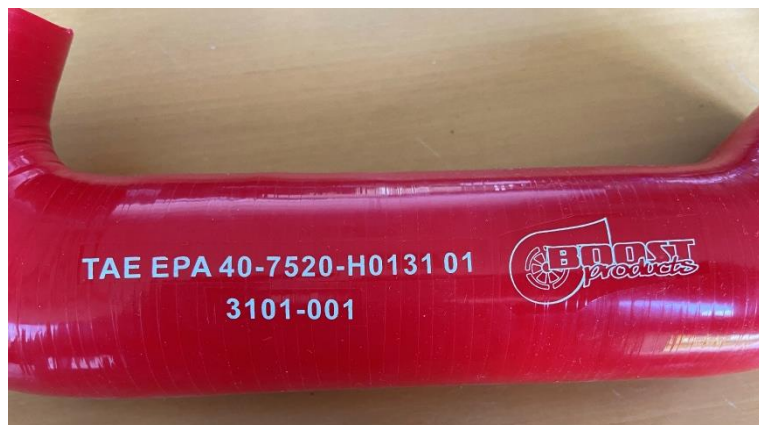
**Remarks:** Only the hoses of the manufacturer "BOOST products" with batch no. 3101-001 are affected. These hoses are not pressure stable and must be replaced.

Figure 2: turbocharger hose of batch 3101-001
