SB TMG 300-0001 P1, Revision 4

# SERVICE BULLETIN

**Subject:** Time Between Replacement (TBR) and Time Between Overhaul (TBO)

**Type affected:** Centurion 3.0 (CD-300)

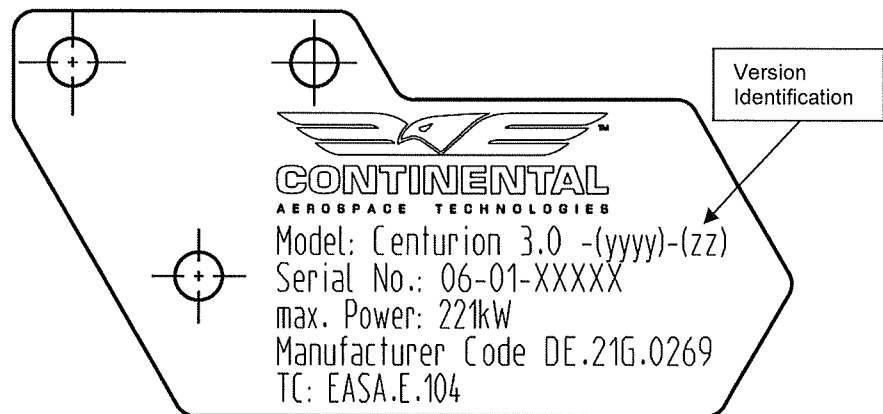
Fig. 1 Engine Version Identification

Identification of Engine Version on Type Plate:
