SB TMG 601-1011 P1, Rev.2

SERVICE BULLETIN

Subject: Engine mount inspection - P/N 20-7120-H0037 03 only

Type affected: Cessna C172 (Reims F172) with
TAE 125-02-99 or TAE 125-02-114
as well as engine mount P/N 20-7120-H0037 03

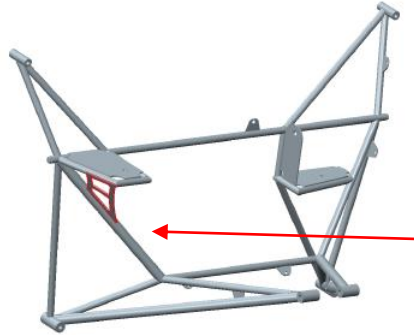
Figure 1: Position Overview

The bracket shown in figure 1 is generally welded on by one seam on the inner and outer side at each bracket end (4 seams in total). Each seam is a sectional welding, see figure 4 and 5. For the above listed engine mount serial numbers the red marked welding seams (inner side) shown in figure 2 resp. 4 are missing.

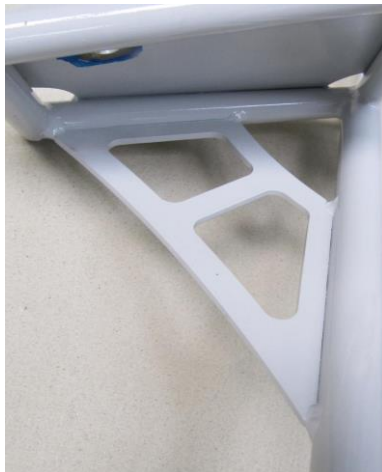
Figure 3: Missing welding seams

An incorrect welded engine mount has been successfully tested statically and on fatigue at Technify Motors GmbH. The tests show that the missing welding seams are structurally uncritical. The airworthiness is not affected. However, the affected welding seams have to be inspected more specifically every 100 flight hours.
