SB TMG 601-1012 P1, Rev. 1

SERVICE BULLETIN

Subject: Modification of the GARMIN G1000 interface.

Type affected: Cessna C172-S with TAE 125-02-114.

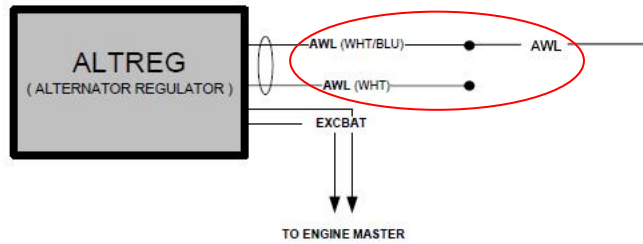
Figure 3: AWL lines pre modification

Reason: Faulty Alternator warning indication.

- Look for the white wire of the AWL loom (free wire end) installed behind the PFD.
- Look for the white/blue wire of the AWL loom connected to line AWL.

- Disconnect the line AWL from AWL (WHT/BLU).
