SERVICE BULLETIN

Service Bulletin No. / Date: SB TMG 601-1013 P1, Initial Issue / March 13, 2019

Subject: Starter Circuit Breaker (10 Amps.).

Type affected: Cessna C172-S with TAE 125-02-114.

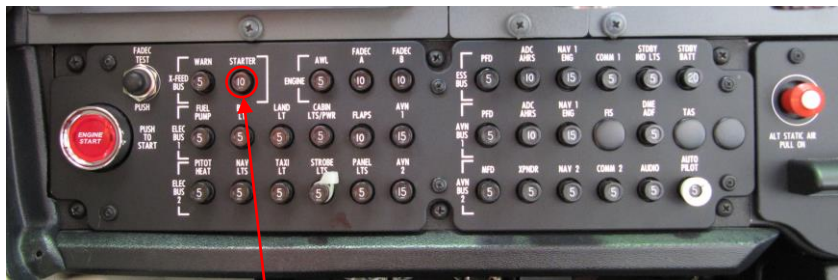
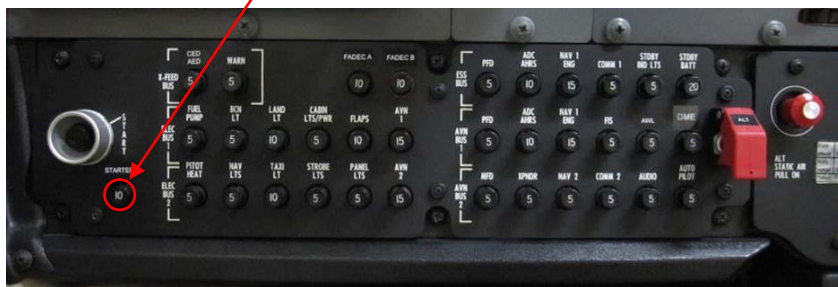
Technify Motors GmbH noticed that in some cases the 10 Amps STARTER Circuit Breaker is not installed as required per Installation Manual IM-20-02S R/S G1000. Instead, a 5 Amps Circuit Breaker is installed or reused. The 5 Amps CB is not sufficient to protect the circuit during engine start, especially during cold engine start.

*Position of the STARTER CB
(depending on installed CB-Panel)*

- Verify if a 10 Amps STARTER Circuit Breaker is installed. Refer to figures below for the position of the CB.
- If a 10 Amps CB is installed the aircraft has been correct retrofitted.
- If a 5 Amps CB (or other) is installed the aircraft has **not** been correct retrofitted. The installed CB must be replaced. Refer to step 3.

- ◆ **Note:** Please contact the technical support of Technify Motors GmbH for providing the required 10 Amps CB.
- Disconnect all batteries
- Remove the installed STARTER CB in accordance with the original Aircraft Maintenance Manual.
- Install NE-0000-00428 01 in reversed order.
- Check the correct function of the CB (engaged / disengaged) via continuity tester.
- Reconnect all batteries.
- Start the engine according to POH.
