# SERVICE BULLETIN

**Service Bulletin No. / Date:** SB TMG 691-1004 P1, Initial Issue / March 02, 2017

**Subject:** Water separator

**Type affected:** All Diamond DA40 D

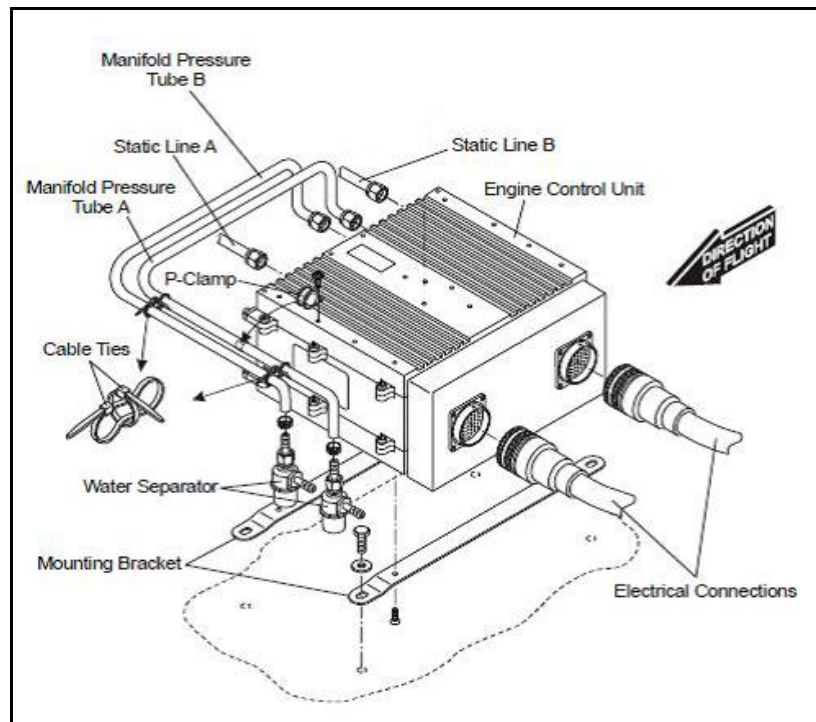
- Remove the pilot seat i.a.w. the original A/C AMM.
- Check if an original water separator system is installed.  
See figure below.

- If no original water separator system is installed carry out Diamond Service Bulletin RSB D4-104/1 or later issue.
  - If an original water separator system i.a.w. RSB D4-083 is installed carry out Diamond Service Bulletin RSB D4-083/1 or MSB D4-104/1 (*resp. later issues of both*).  
Alternatively, install the water separators P/N 50-3940-E0020 03 (DAI P/N: D60-9076-14-01) according to section 4 "Water Separator Installation".
- ◆ Note: If the FADEC D48 has been replaced by a FADEC D4 please also take into account Diamond Service Bulletin OSB D4-098/1.

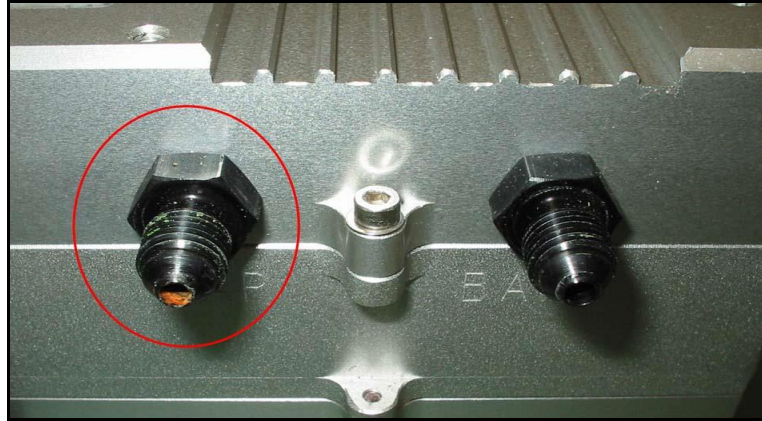
**Reason:** To prevent a possible damage to the FADEC integrated MAP-sensors by condensed water

- Remove both MAP lines to check the FADEC fittings.
- Inspect the FADEC fittings for water, water residues, corrosion, sediments etc. Refer to the picture below.

**If such damages are detected, the FADEC needs to be replaced.**
