## SERVICE BULLETIN

**Service Bulletin No.** SB CG 300-1000 P1, Revision 1  
**Date:** April 25, 2022

**Subject:** Check the installation of the gearbox oil cooler

**Type affected:** Centurion 3.0 (CD-300)

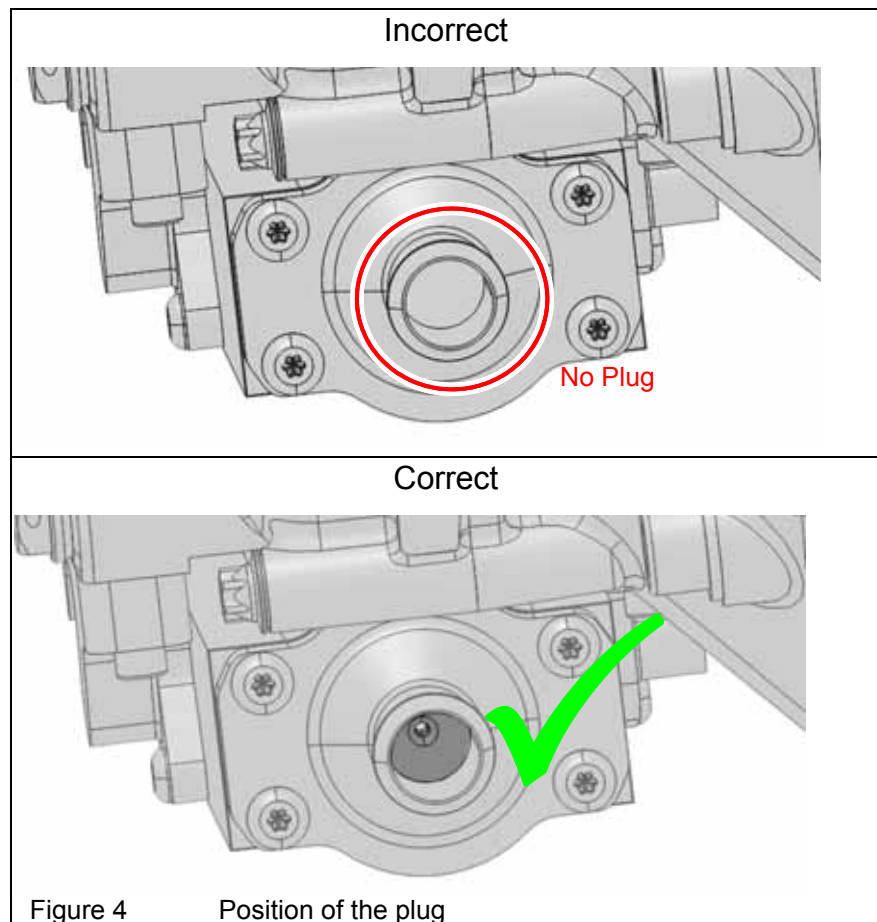
Figure 4 Position of the plug

**Reason:** It is possible that the oil cooler is incorrectly fitted. This can lead to an overheated gearbox and finally to a partial loss of power.

3. Check the position of the plug at the right side (gearbox front view) of the oil cooler.

If the plug is installed correctly:

4. Continue with step 10.

If the plug is installed incorrectly:

5. Drain the gearbox oil, refer OM-06-01.
6. Remove the four screws of the oil connection to remove the oil cooler. Discard the O-rings and screws.

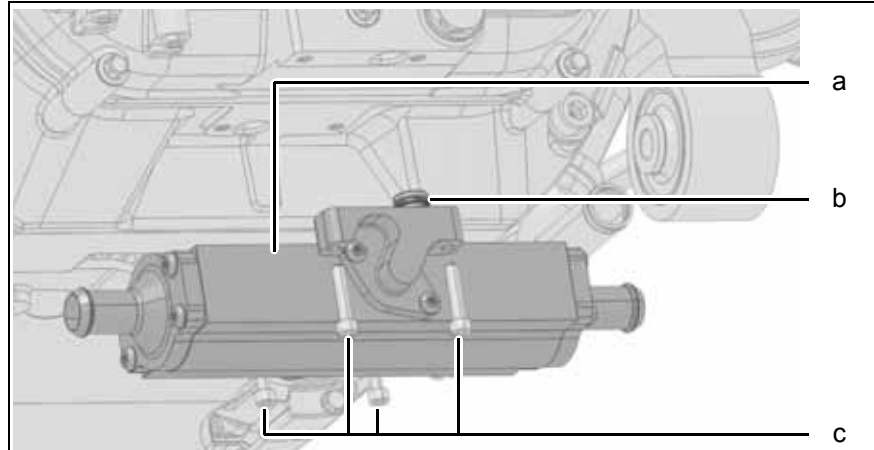
Figure 5 remove the oil cooler

- a Oil cooler
- b O-ring 12x2
- c Hexagon socket head cap screw M5x25

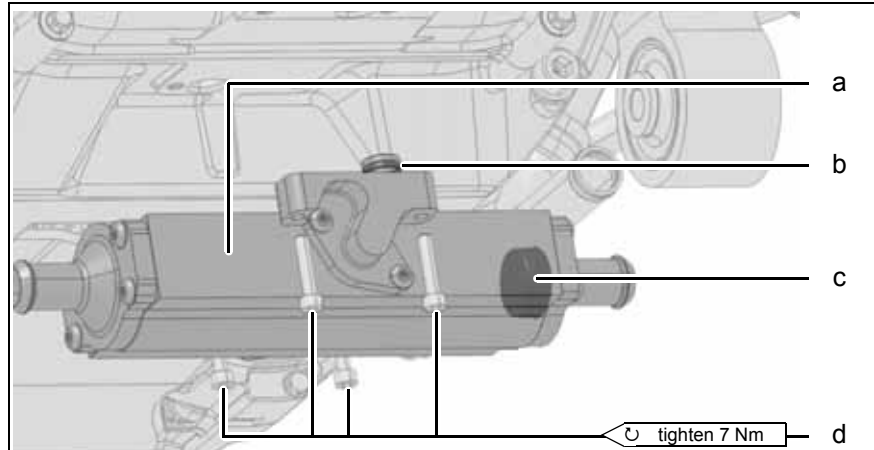
Figure 7 install the oil cooler

- a 06-7212-K006703 Oil cooler  
b NM-0000-0146001 O-ring 12x2  
c Plug  
d NM-0000-0076901 Hexagon socket head cap screw M5x25

8. Install the oil cooler, make sure the plug is on the correct side, see Figure 7. Use new O-rings and screws.

**Tightening Torque:**  
7 Nm
