SB TMG 125-1020 P1, Revision 1

# SERVICE BULLETIN

**Subject:** Gearbox Oil Leak Inspection

**Type affected:** TAE 125-02-99 and TAE 125-02-114

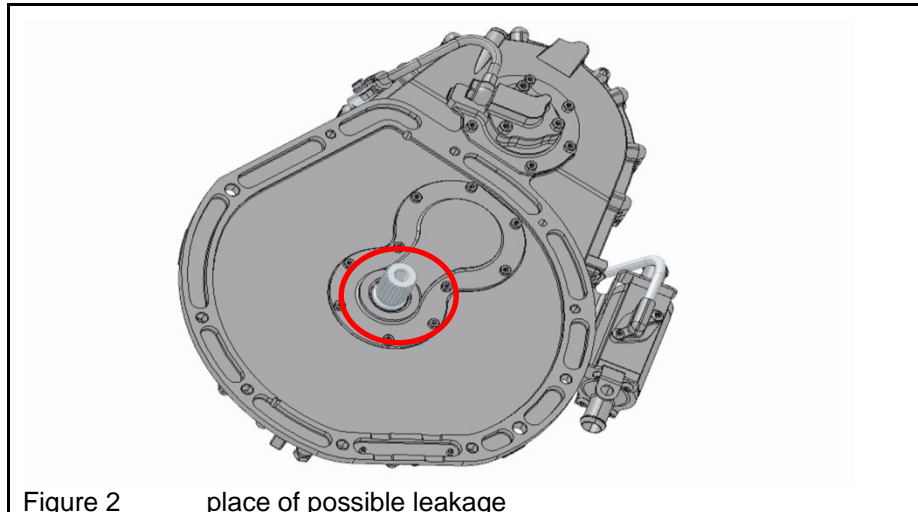
**Reason:** Radial shaft sealing ring may not seal properly due to an improper lapped gearbox drive shaft. This can lead to an oil leak and a slipping clutch and finally to a loss of power.

- Remove the gearbox and replace the clutch by dual mass flywheel in accordance with RM-02-02, Chapter 72-10.18, Issue 3, Revision - or later approved revisions.
- Inspect the gearbox, check the rear radial shaft sealing ring on the gear shaft for oil leakage and moisture, see Figure 2 and Figure 3.

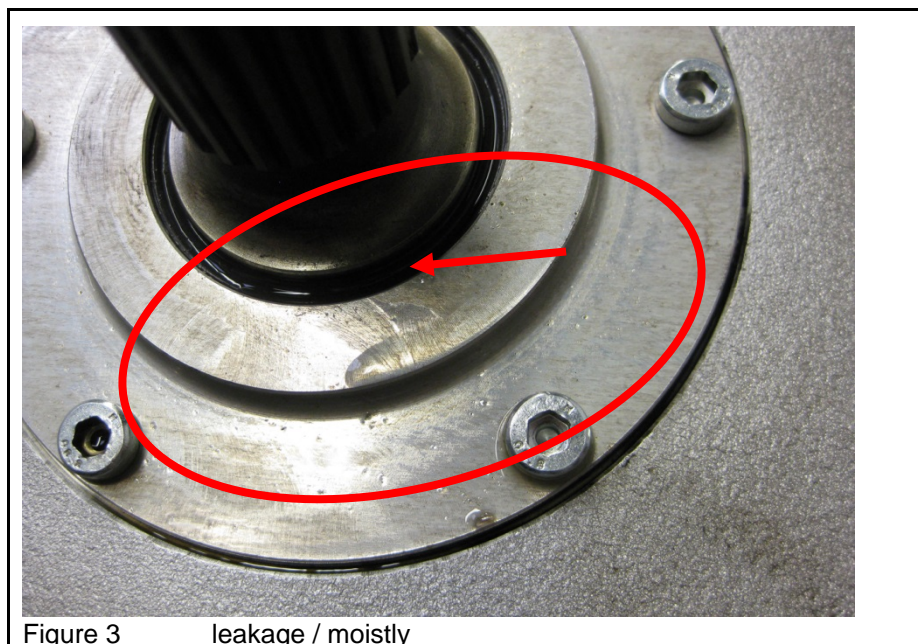
- If there is a leakage or moisture, see Figure 3, replace the gearbox.

◆ Note: The clutch has to be replaced by the dual mass flywheel in each case.
