SERVICE BULLETIN

Service Bulletin No. / Date: SB TMG 300-0001 P1, Revision 3 / February 7, 2024

Subject: Time Between Replacement (TBR) and Time Between Overhaul (TBO)

Type affected: Centurion 3.0 (CD-300)

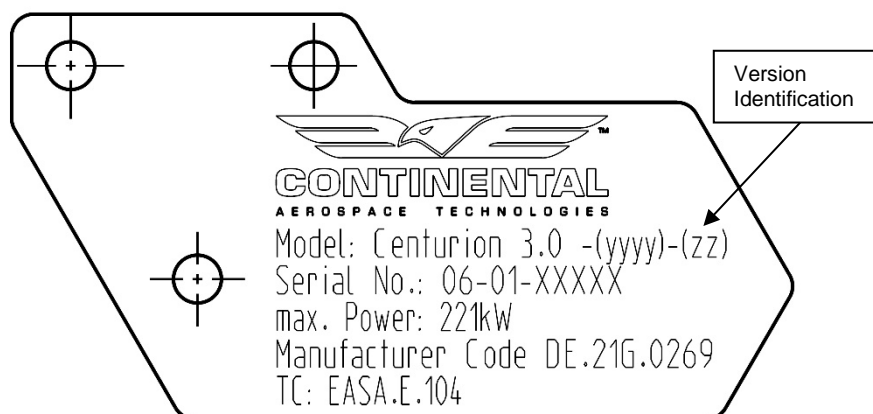
Fig. 1 Engine Version Identification

Identification of Engine Version on Type Plate:
