SB TMG 300-0001 P1, Revision 5

# SERVICE BULLETIN

**Subject:** Time Between Replacement (TBR) and Time Between Overhaul (TBO)

**Type affected:** Centurion 3.0 (CD-300)

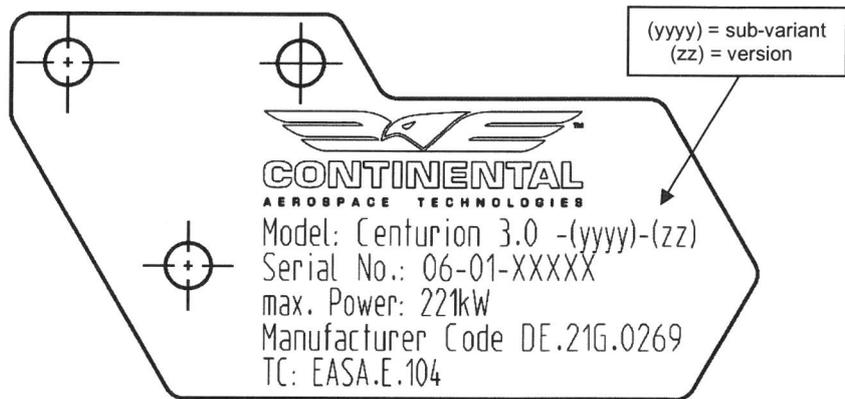
Fig. 1 Engine Identification

Identification of engine sub-variant (yyyy) and version (zz) on type plate:
