SI TMG 125-0001, Initial Issue

# Service Instruction

**Subject:** Installation sealing ring of the gearbox oil drain plug

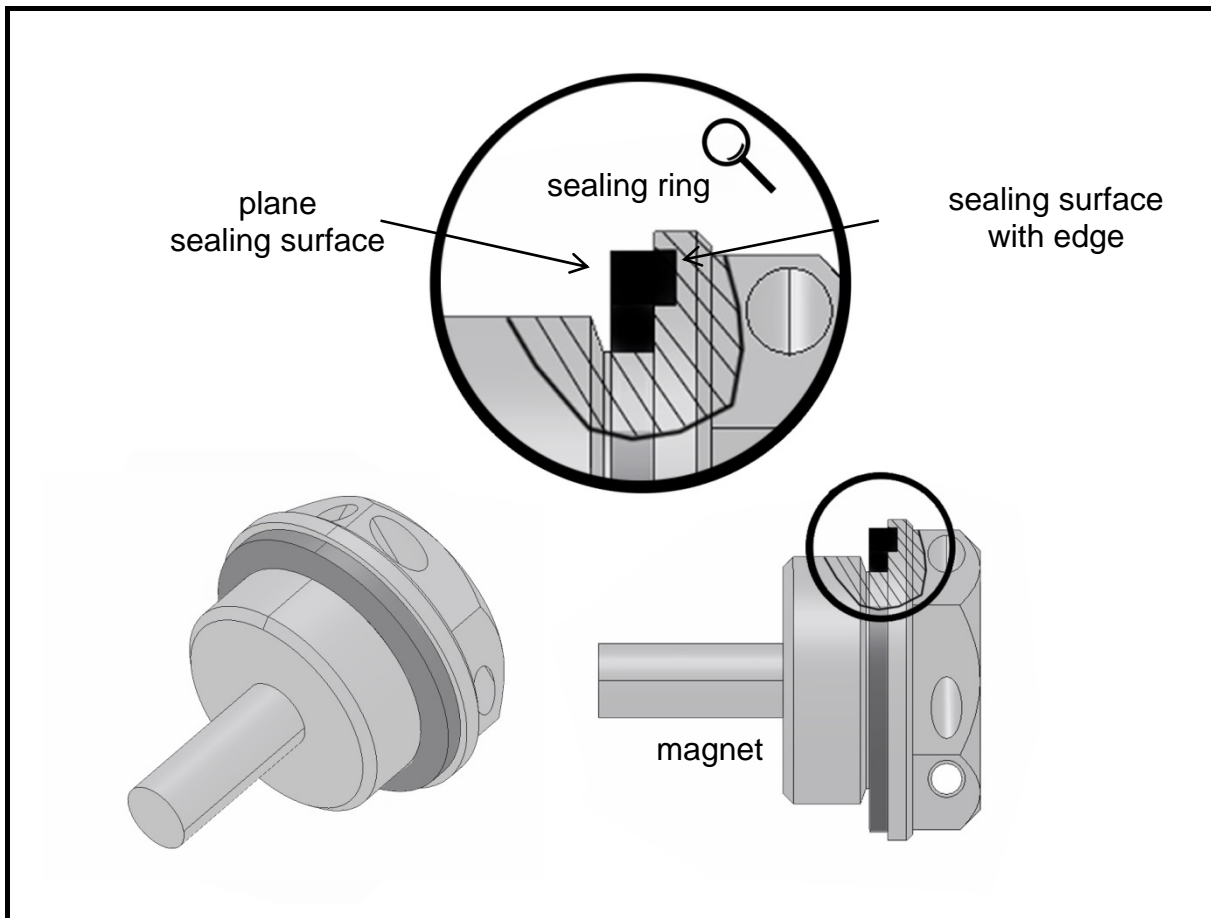
Figure 1

**Reason:** Improperly installed flat sealing ring in field.  
Oil leaks due to improperly installed seal.

**Correction:** Installation of P/N: NM-0000-0188601

- 
- **CAUTION:** The sealing ring has 2 different sealing surfaces.  
The plane surface of the sealing ring must face the magnet.
-

The exact installation must be observed.
