Service Letter

Service Bulletin No. /
Date: SL TMG 125-1004, Initial Issue / October 10, 2014

Subject: Inspect the attachment of the alternator loom

Type affected: TAE 125-02-99 and TAE 125-02-114

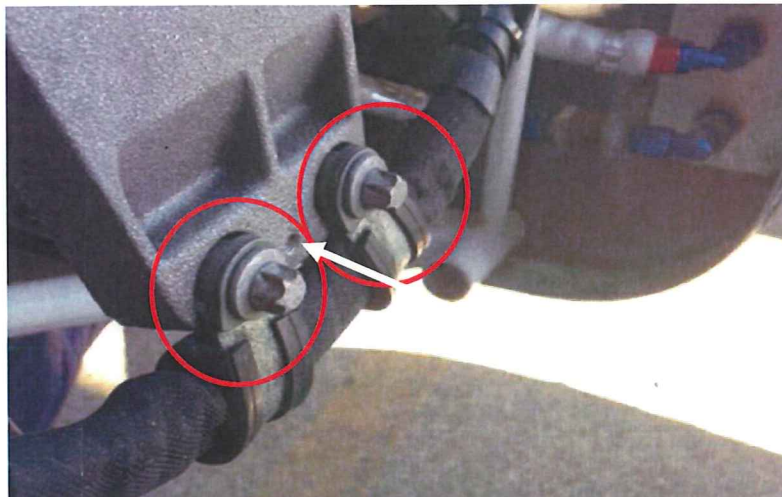
Reason: We have detected maintenance problems with some incorrect mounted alternator looms.
 Risk to loosening the screws and further damages, in case of a wrong mounted alternator loom. Because the screws may be too short. See Figure 1.

◆ **Note:** If the *alternator support* with the tapped hole is installed (see the white arrow in Figure 1).
 The alternator wiring harness must be mounted as shown in Figure 2.

Figure 1: WRONG mounted alternator loom

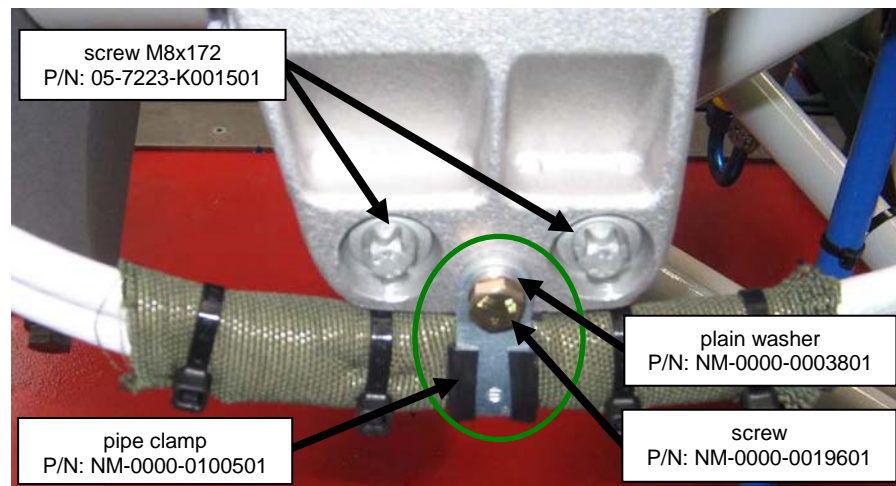
Figure 2 alternator support WITH the tapped hole

- ◆ **Note:** Check that the correct screws M8x172 are installed.
The bottom screws on the alternator support must be screws with external torx M8x172-8.8 P/N: 05-7223-K001501. See Figure 2.

1. Remove the wrong attachment.
2. Attach protective sleeve (2x150mm) (P/N: NE-0000-0069301) around the lines.
3. Install the clamp (P/N: NM-0000-0100501) around the protective sleeve and the lines.
4. Attach the clamp with a screw (P/N: NM-0000-0019601) and a washer (P/N: NM-0000-0003801) on the alternator support. See Figure 2.

Tightening Torque:
10 Nm (89 inch-lbs.)

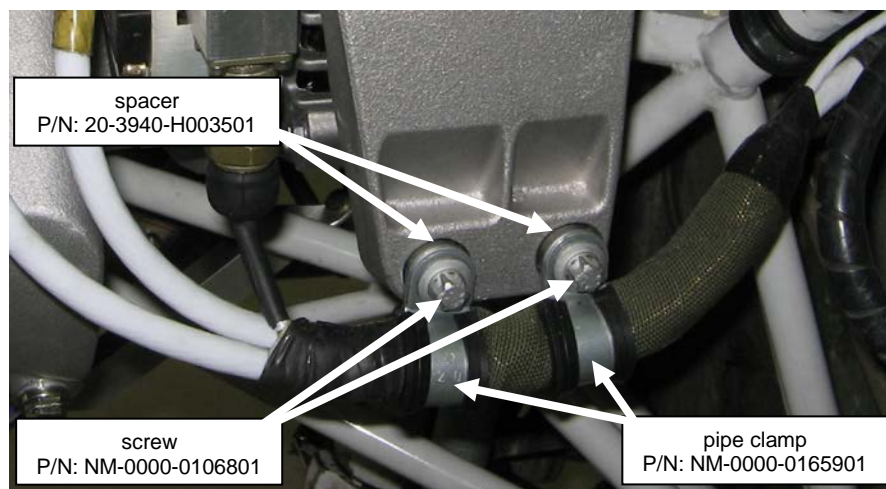
Figure 3 alternator support WITHOUT the tapped hole

- ◆ **Note:** Check that the correct screws M8x190 are installed.
If not, follow the instructions below.

1. Remove the wrong attachment.
2. Attach protective sleeve (2x150mm) (P/N: NE-0000-0069301) around the lines.
3. Install the clamps (P/N: NM-0000-0165901) around the protective sleeve and the lines.
4. Attach the clamps, each with a spacer (P/N: 20-3940-H003501) and the screws (P/N: NM-0000-0106801) of the alternator support.
See Figure 3.

Tightening Torque:
20 Nm (177 inch-lbs.)
