SL TMG 000-1005, Revision 1

Service Letter

Subject: Improper protection against chafing

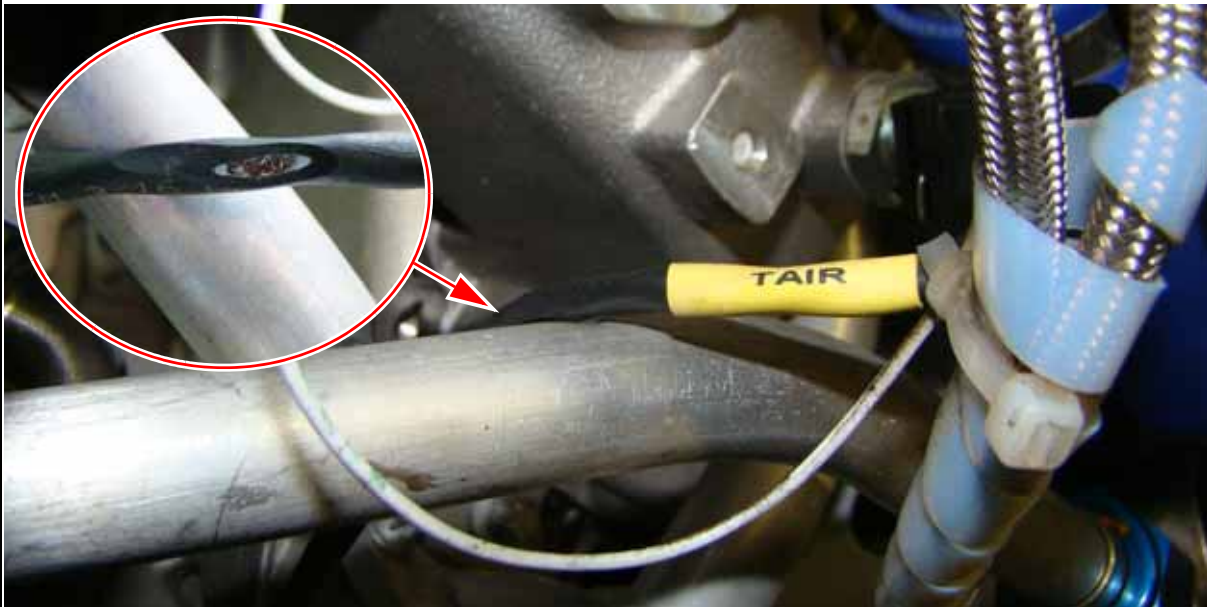
Incorrect

Figure 1 chafing spot: engine loom

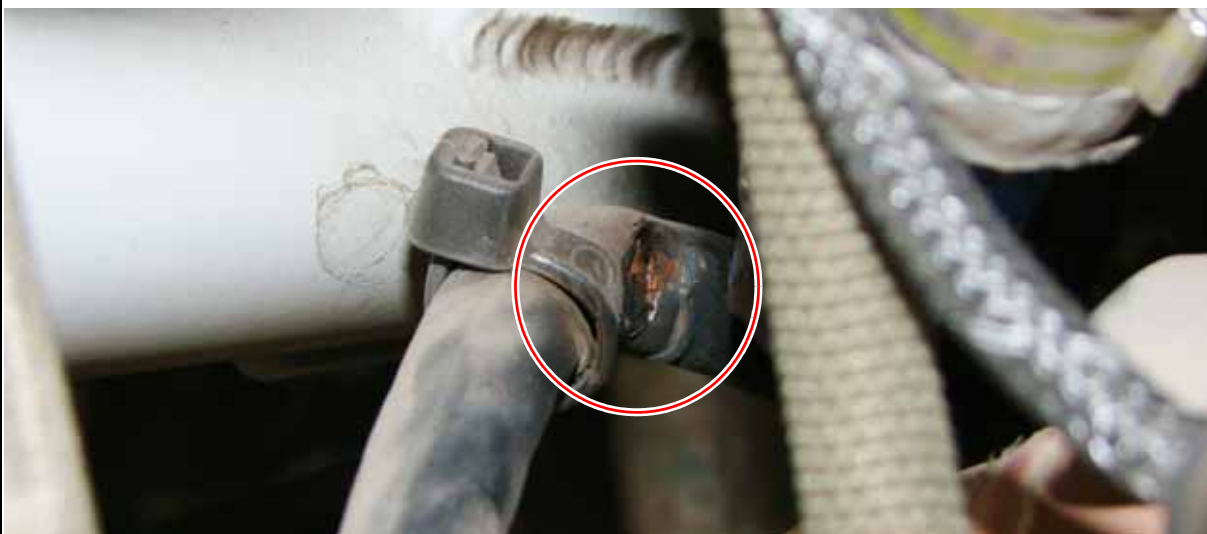
Incorrect

Figure 2 chafing spot: ground cable at engine mount rear right

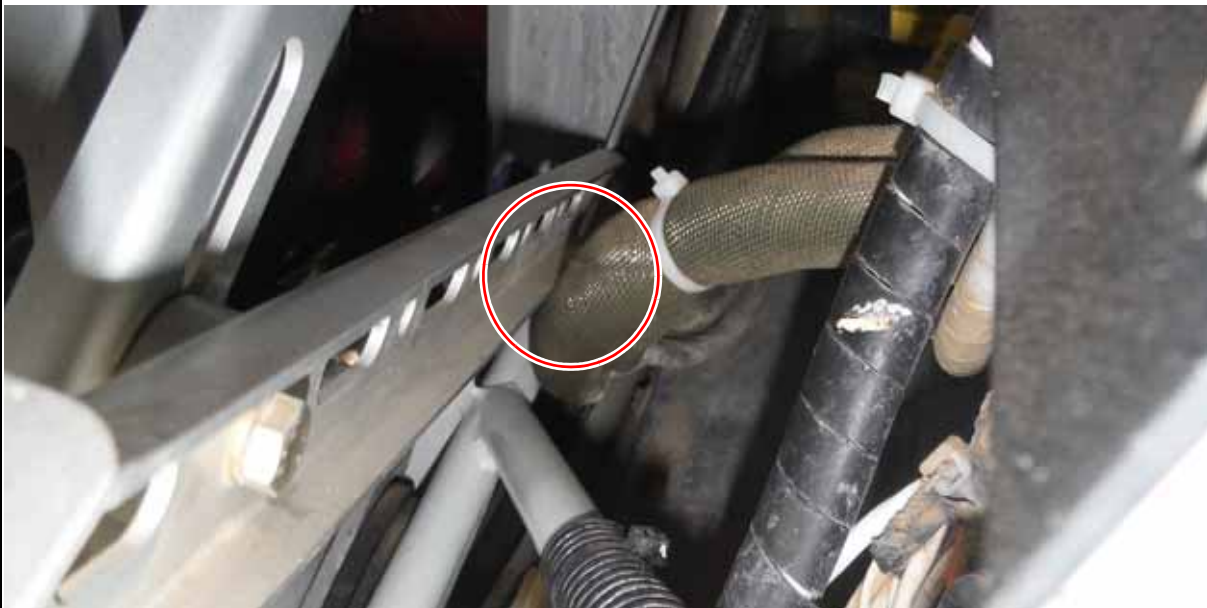
Incorrect

Figure 3 chafing spot: engine mount / engine loom

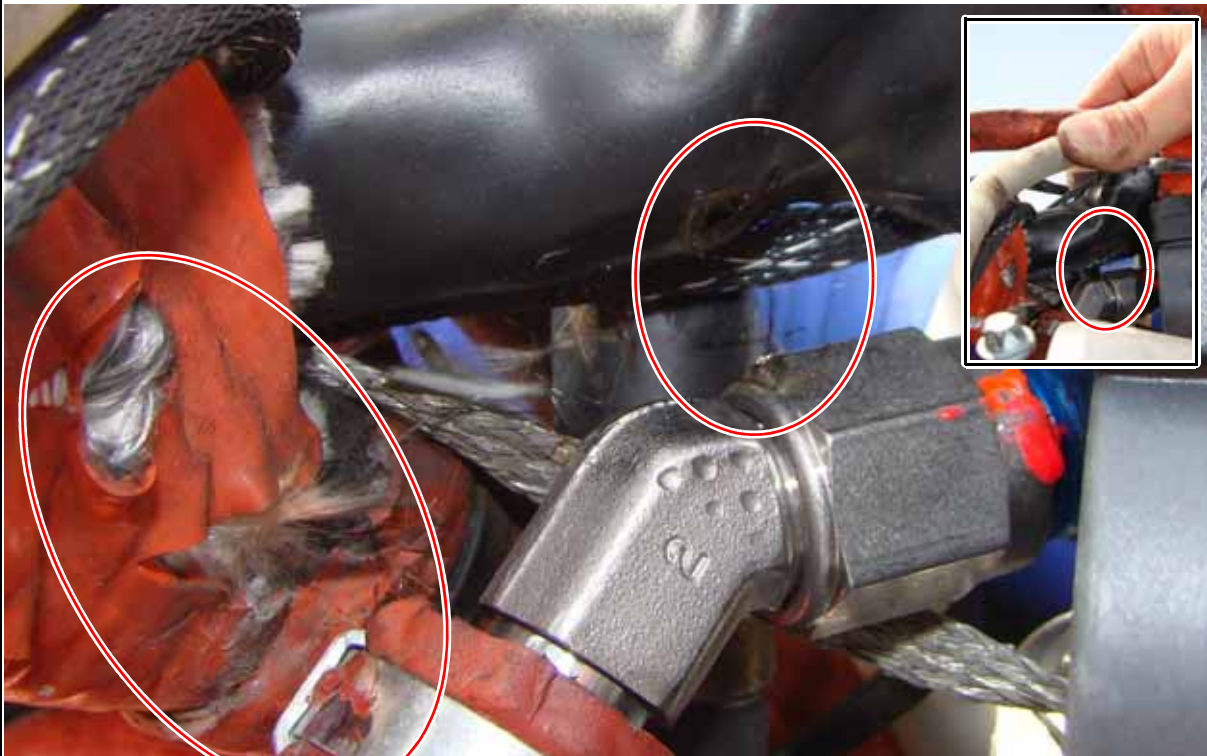
Figure 4 chafing spot:

Incorrect

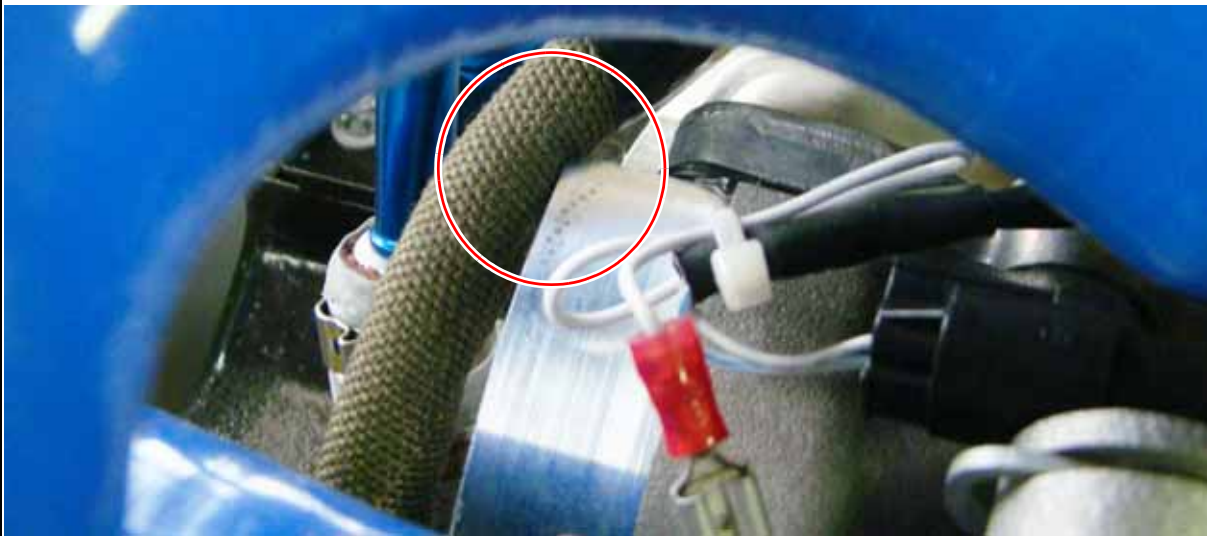
Incorrect

Figure 5 chafing spot: front cover / engine loom

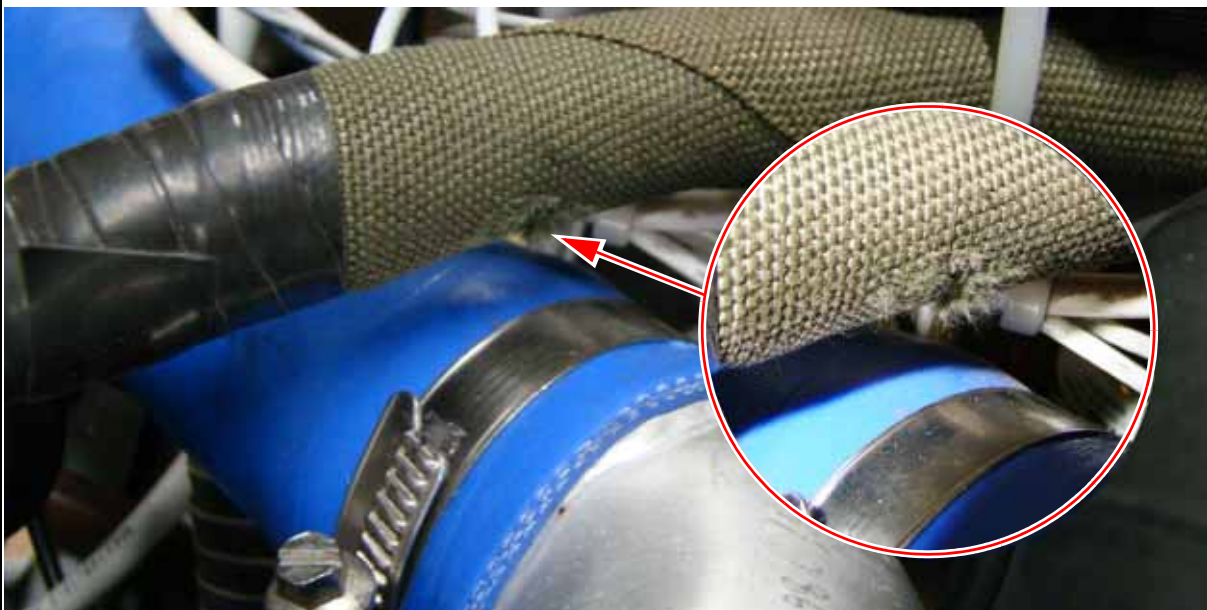
Incorrect

Figure 6 chafing spot: engine loom

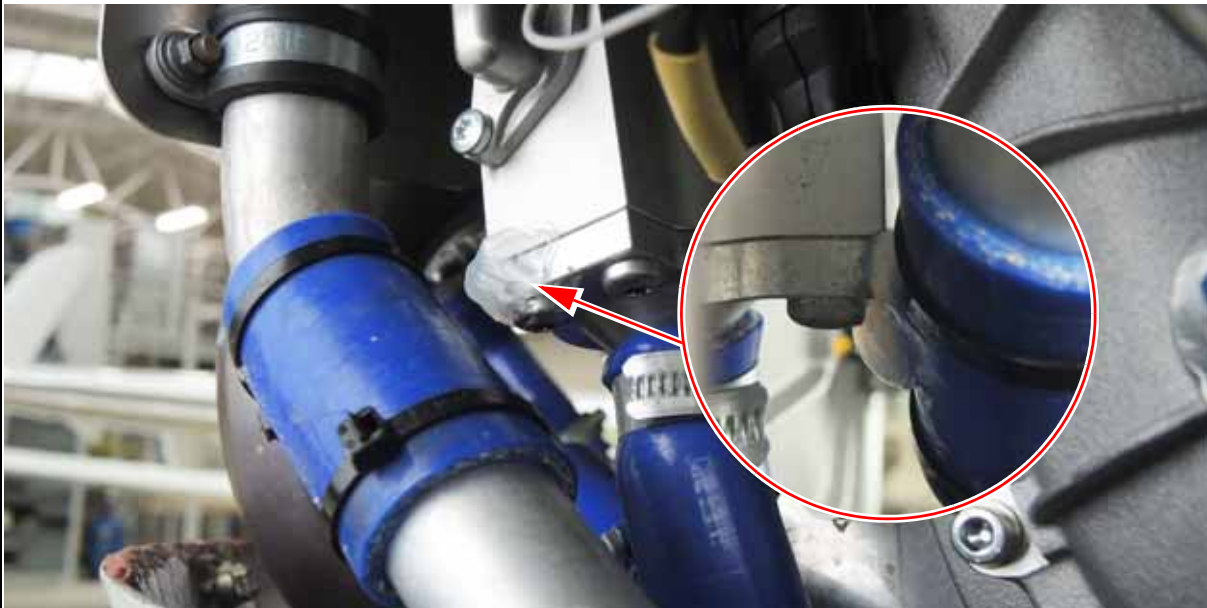
Incorrect

Figure 7 chafing spot: gearbox oil cooler

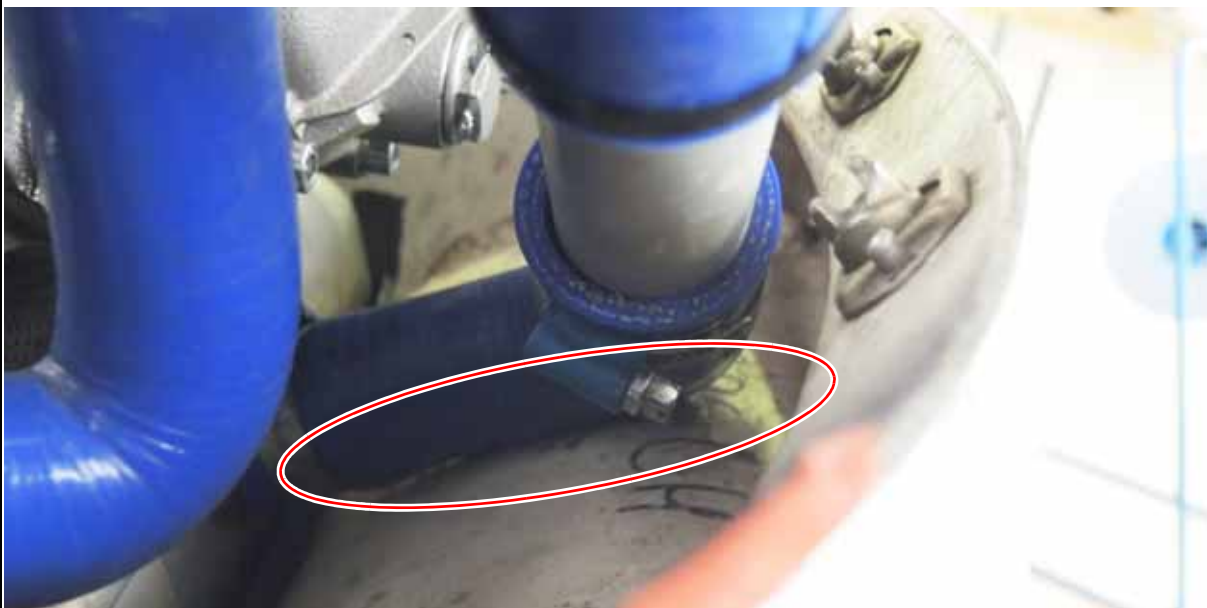
Incorrect

Figure 8 chafing spot: cowling DA42

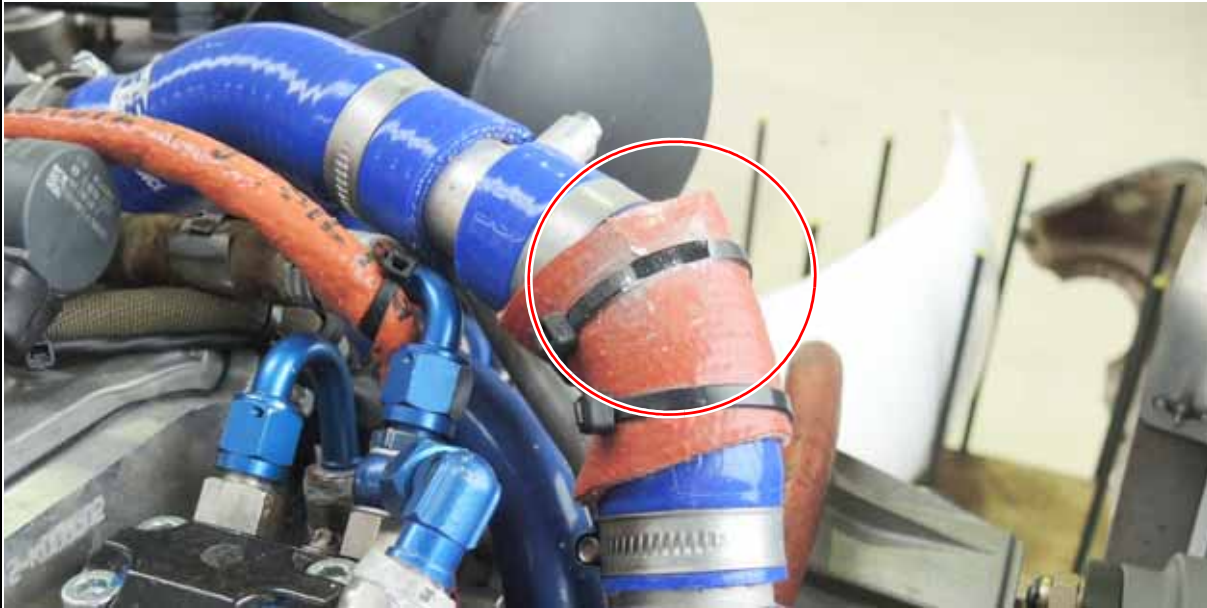
Incorrect

Figure 9 chafing spot: cowling DA42

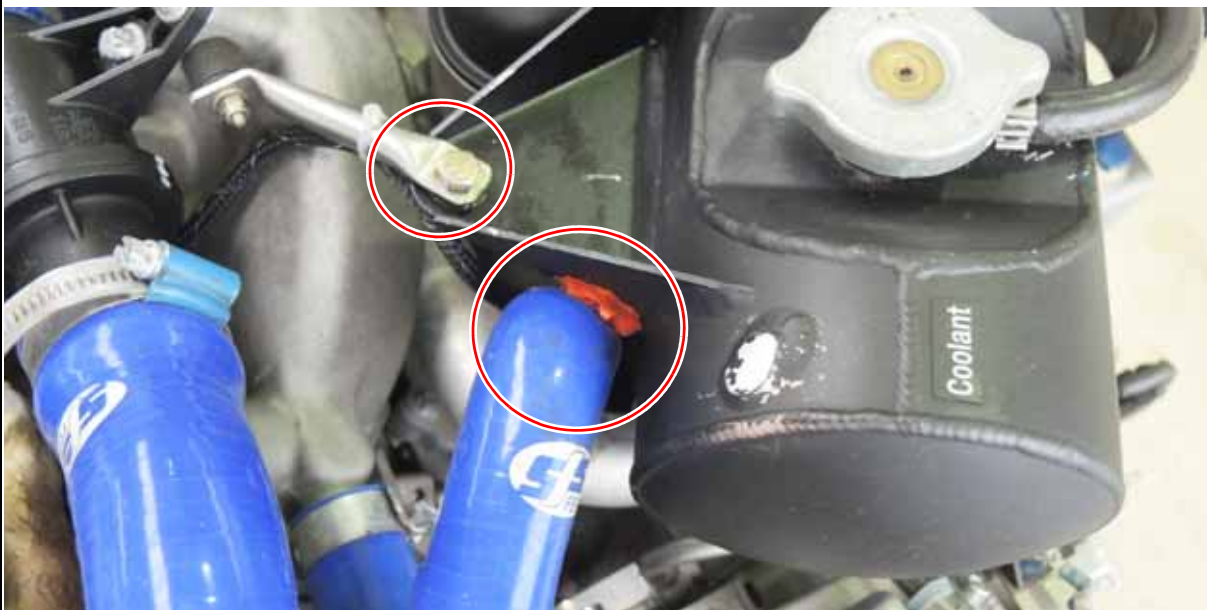
Incorrect

Figure 10 chafing spot: coolant tank DA42, chafing due to incorrect installed bracket

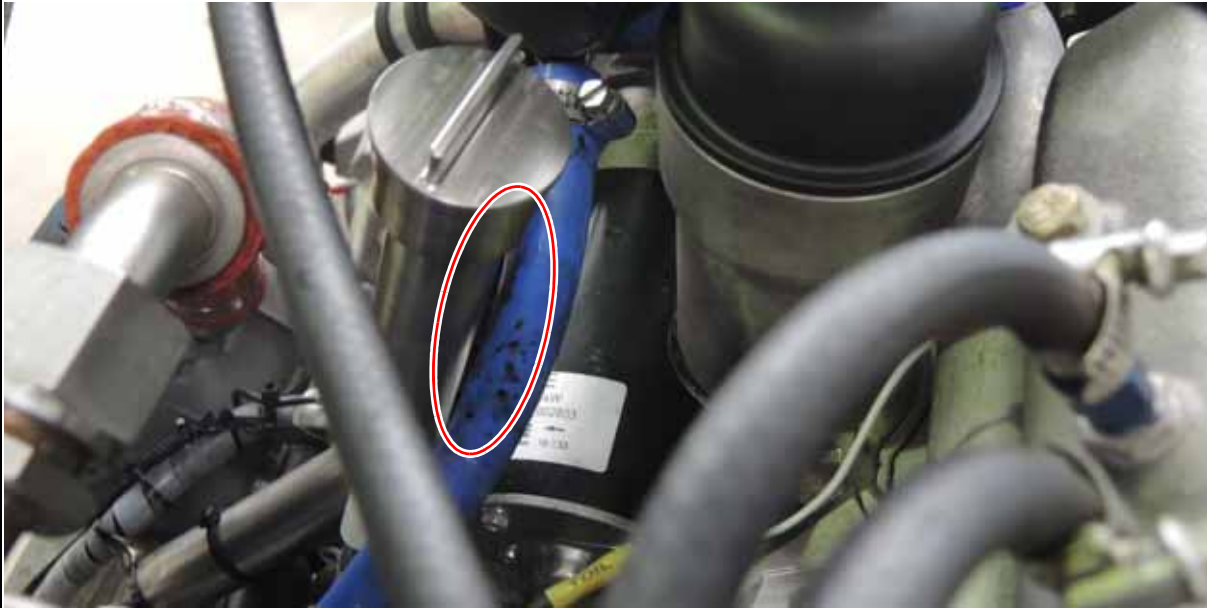
Incorrect

Figure 11 chafing spot: oil tube - missing cable ties

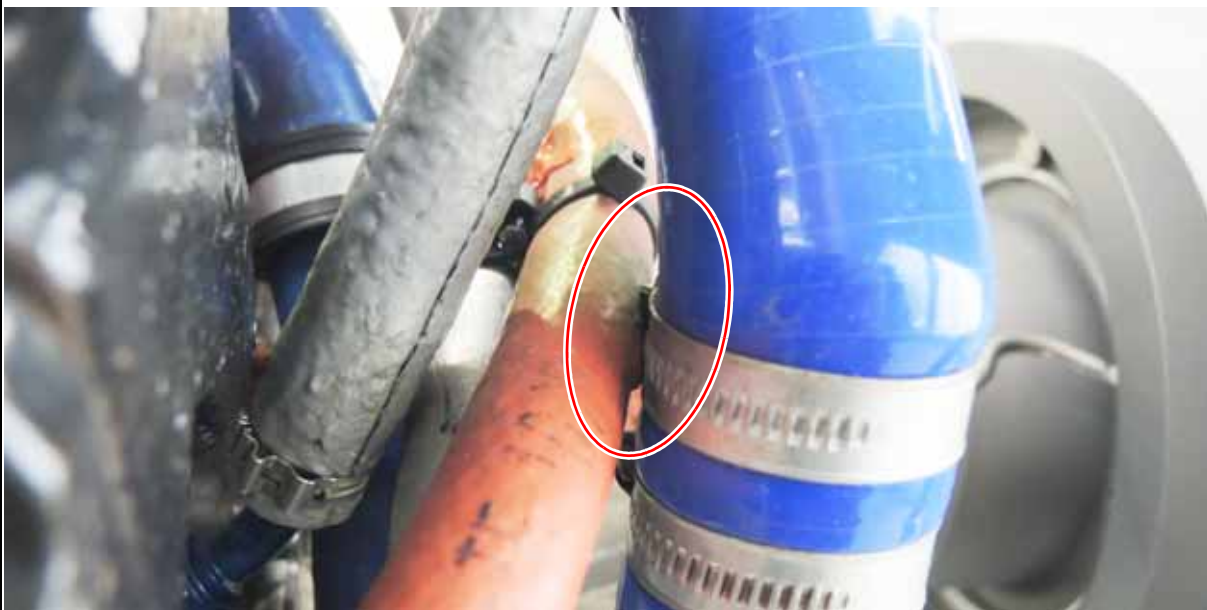
Incorrect

Figure 12 chafing spot: hose clamp water hose

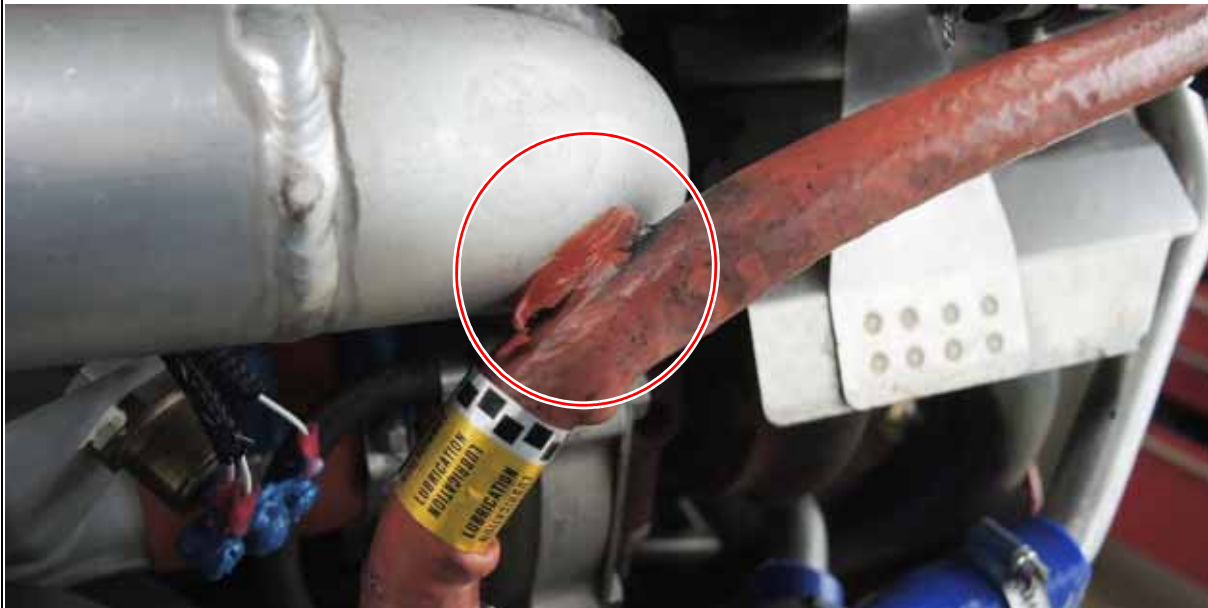
Incorrect

Figure 13 chafing spot: turbo pipe
