**Technify  
Motors**

## Service Letter

**Service Bulletin No. / Date:** SL TMG 125-1002, Initial Issue / September 17, 2013

**Subject:** Operation with Dual Mass Flywheel (DMF)

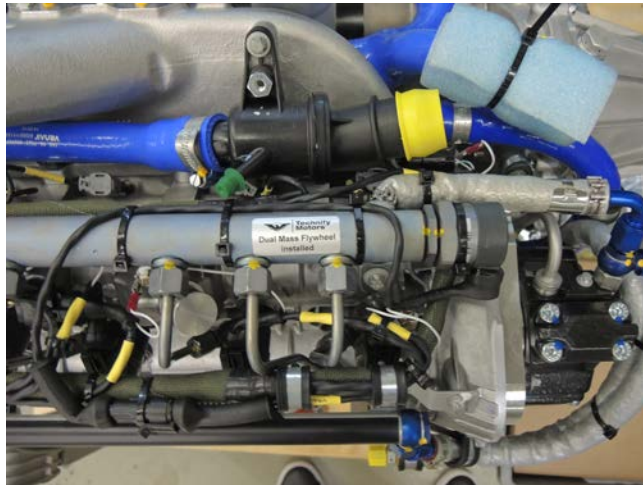
Fig. 1 – Label Dual Mass Flywheel

- ◆ Note: A label is visible on the fuel rail of the engine, if a dual mass flywheel is installed. See Fig. 1.
- ◆ Note: The mappings to be used are listed in Service Bulletin TM TAE 000-0007 Rev. 21 or later approved revision.

**Correction:** Observe the revised restart in-flight procedure, if a dual mass flywheel is installed. The revised procedure applies to both engines, even if the dual mass flywheel is installed only on one of two engines.  
Refer to the applicable Airplane Flight Manual (AFM) of the DA42.
