SB TMG 651-1004 P1, Rev. 2

SERVICE BULLETIN

Subject: Start Monitoring Loom and Mapping
Starter Info Board and mapping

Type affected: All Piper PA 28 with TAE 125-02 and Dual Mass Flywheel (DMF)

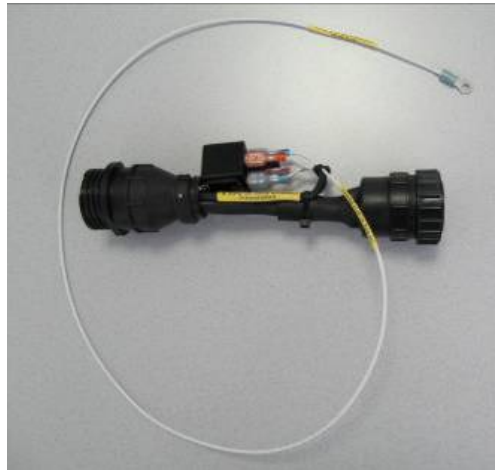
- Disconnect the main, excitation and FADEC backup battery. Ground the aircraft.
- There are two versions of the start monitoring loom:
 - P/N 20-3940-E024801 (14V)
 - P/N 20-3940-E024901 (28V)

- Install the appropriate start monitoring loom behind the cockpit panel between light panel loom and engine loom in accordance with Figure 1a.

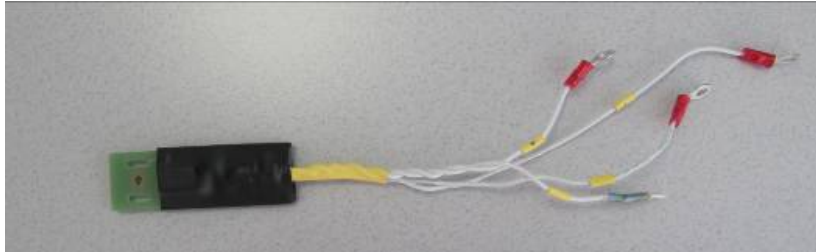
- Disconnect the main, excitation and FADEC backup battery. Ground the aircraft.
- Starter Info Board: (PA28 181 with G1000 only)
P/N 40-8010-E000401 (28V)

- Install the Starter Info Board in the Overhead Switchpanel in accordance with Figure 1b and Figure 1c.
