## SERVICE BULLETIN

**Service Bulletin No.** SB CG 300-1000 P1, Revision 1  
**Date:** April 25, 2022

**Subject:** Check the installation of the gearbox oil cooler

**Type affected:** Centurion 3.0 (CD-300)

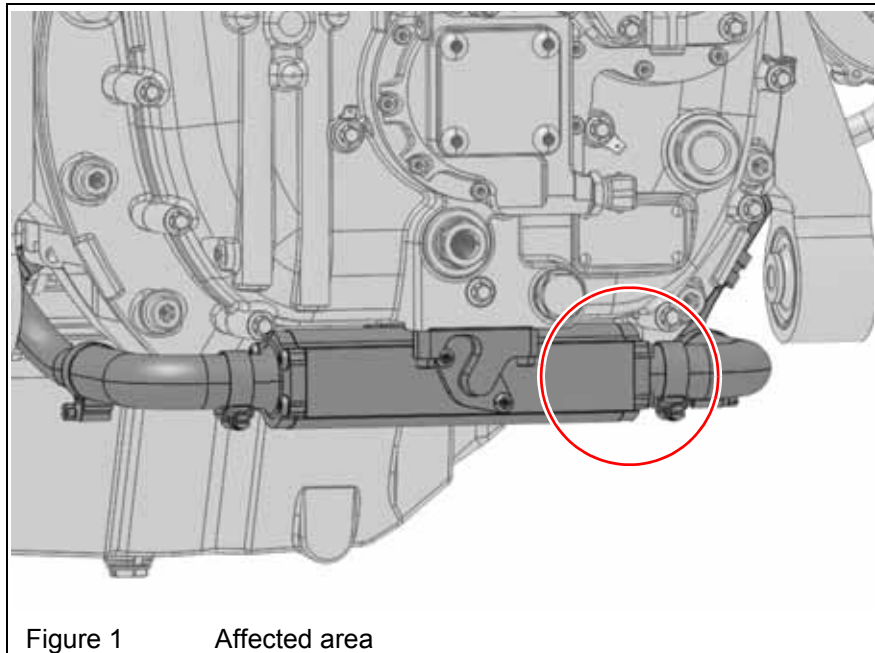
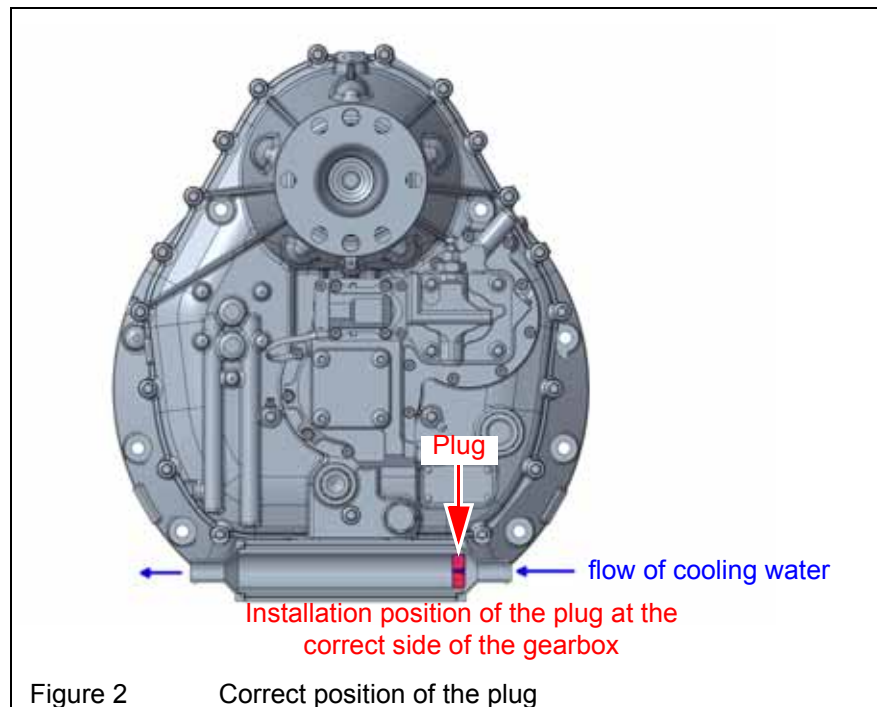
Check installation position of the plug, correct if necessary.

1. Disconnect the oil cooler from the coolant supply.

2. Remove the coolant hoses from the oil cooler.
