SB TMG 125-1020 P1, Revision 1

# SERVICE BULLETIN

**Subject:** Gearbox Oil Leak Inspection

**Type affected:** TAE 125-02-99 and TAE 125-02-114

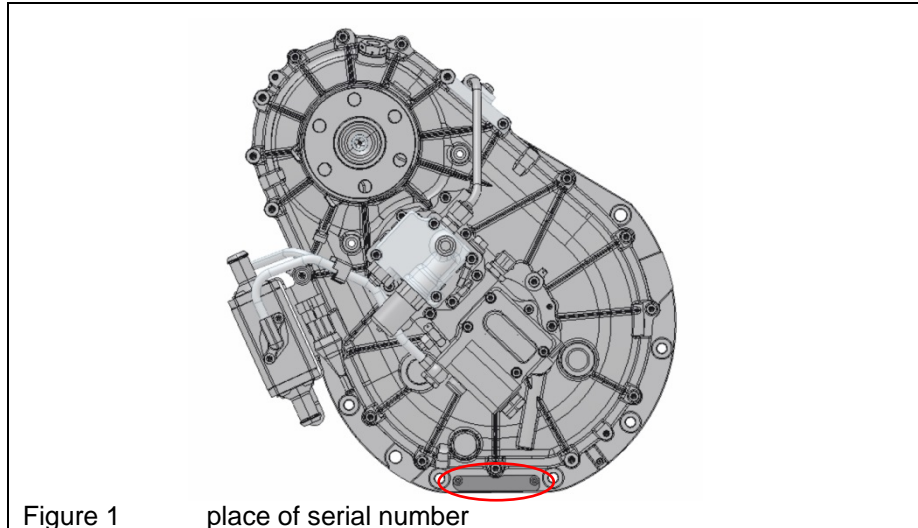
**Reason:** Radial shaft sealing ring may not seal properly due to an improper lapped gearbox drive shaft. This can lead to an oil leak and a slipping clutch and finally to a loss of power.

- Remove the gearbox and replace the clutch by dual mass flywheel in accordance with RM-02-02, Chapter 72-10.18, Issue 3, Revision - or later approved revisions.
- Inspect the gearbox, check the rear radial shaft sealing ring on the gear shaft for oil leakage and moisture, see Figure 2 and Figure 3.

- If there is a leakage or moisture, see Figure 3, replace the gearbox.

◆ Note: The clutch has to be replaced by the dual mass flywheel in each case.
